ARCHIVES
of
FOUNDRY ENGINEERING

On Degradation of Cast Iron Surface- -Protective Paint Coat Joint

M. Tupaj ^{*a}, A.W. Orłowicz ^a, A. Trytek ^a, M. Mróz ^a, G. Bąk ^b, T. Abram ^b^aDepartment of Casting and Welding, Rzeszow University of Technology, al. Powstańców Warszawy 12, 35-959 Rzeszów^bDrummonds, ul. Lipińskiego 109, 38-500 Sanok

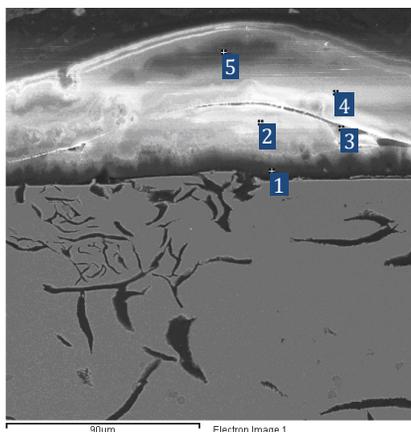
Metallographic analysis of specimens cut out in the plane perpendicular to the painted surface allowed to conclude that two paint coats were applied in the production process. The coat differed from each other in chemical composition, and in particular in chlorine content. Example results of metallographic examination of the paint coat are presented in Fig. 1. The first coat was rich in chlorine (above 17% Cl), while the second revealed low chlorine content (0.44–1.89% Cl, Fig. 1).

Spectrum No.	Element content, % wt.		
	C	O	Cl
1	71.14	10.95	17.92
2	66.87	16.13	17.00
3	75.79	19.61	4.59
4	84.36	15.20	0.44
5	89.22	8.89	1.89

Fig. 1. An example specimen microstructure in transverse section with two layers of paint. Note a discontinuous chlorine-rich paint layer (point 2) and continuous layer of paint with low chlorine content (points 4 and 5)

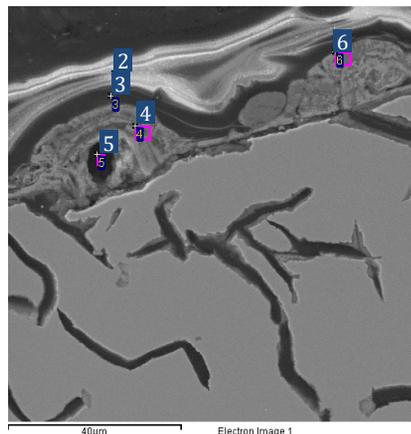
Results of microscopic examination indicate presence of corrosion traces passed over in the surface cleaning process in the form of convex oxide particles adhering to the casting surface (Fig. 2). This is evidenced by presence of a thin paint layer over the areas where oxide particles are found. Observed were also oxide layers adhering to casting surface and covered with a paint coat of normal thickness (Figs. 3, 4). Moreover, discontinuities of the paint coat could be visible with layers of oxides adhering locally to the substrate (Figs. 5, 6) and corrosion pits emerging on the casting surface, filled with oxides and covered with a layer of paint (Figs. 7, 8). This suggests that the paint could be applied onto a surface of casting some areas which were dampened. In presence of moisture, already under the paint layer, the corrosion process could develop penetrating then the casting material. It turned out that easy corrosion paths run through separation surfaces between flake graphite precipitates and the matrix. The corrosion process was intensified by presence of chlorine which most likely came from the paint used to coat the product.

Spectrum No.	Element content, % wt.				
	C	O	Si	Cl	Fe
2	77.24	22.33	0.00	0.43	0.00
3	68.23	15.74	0.25	7.52	8.25
4	6.78	37.31	1.92	0.00	53.31
5	0.00	0.00	0.00	1.52	98.48
6	12.71	34.70	0.00	2.01	50.58

Fig. 2. An example specimen microstructure in transverse section.

Note oxide particles with convex shapes adhering locally to casting surface and covered with thinned coat poor in chlorine

Location of oxides found on the substrate surface onto which the paint coat was applied suggest two main causes of their presence. The first is the failure to remove oxides from metal surface. This is evidenced by presence of oxides adhering to the casting surface and the paint coat covering them being thinner than in the areas free from oxides. The second cause consists in the casting surface retaining locally some moisture which, in presence of chlorine coming most likely from the paint, became an electrolyte contributing to creation of micro-cells. In such cases, corrosion penetrated deep into the casting wall.

- To ensure that surfaces of painted cast-iron castings will maintain high aesthetic qualities, it is necessary that the substrate will be thoroughly cleansed of any traces of corrosion and made free of micro-residual damp.
- The used paint should not contain chlorine, as presence of the element in areas with micro-residual damp results in occurrence of corrosion micro-cells, creating conditions for penetration of corrosion deep into the casting material.
- The paint coat should have no discontinuities exposing surface of the casting, because in conditions of free access of damp, in particular in atmospheres typical for maritime regions, local corrosion centres can be created.

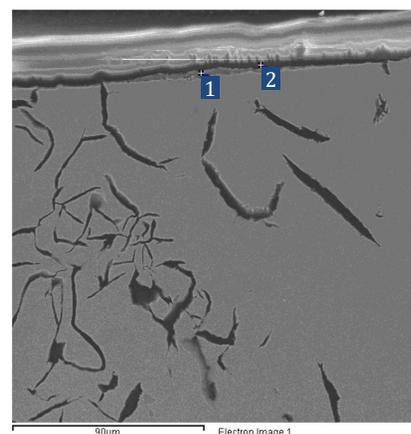
Spectrum No.	Element content, % wt.					
	C	O	Si	P	Cl	Fe
1	15.51	35.71	1.69	1.28	1.16	44.65
2	67.68	16.22	0.00	0.00	12.12	3.97

Fig. 3. An example specimen microstructure in transverse section.

Note a layer of oxides adhered locally to the casting surface and covered with a layer of paint with similar thickness

Graphite precipitates turn out to be easy corrosion paths. The process takes place after application of the paint coat which is evidenced by similar coat thickness on both corrosion centres and corrosion-free areas.

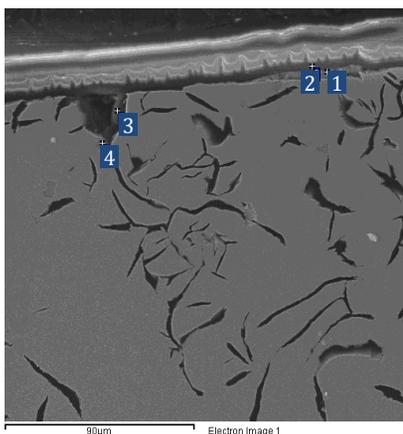
Spectrum No.	Element content, % wt.				
	C	O	Si	Cl	Fe
1	19.51	28.50	1.23	2.44	48.33
2	70.12	15.30	0.00	11.33	3.26
3	99.09	0.00	0.00	0.00	0.91
4	53.60	0.00	1.54	0.00	44.86

Fig. 4. An example specimen microstructure in transverse section. Note a layer of oxides adhered locally to the casting surface and covered with a layer of paint with similar thickness

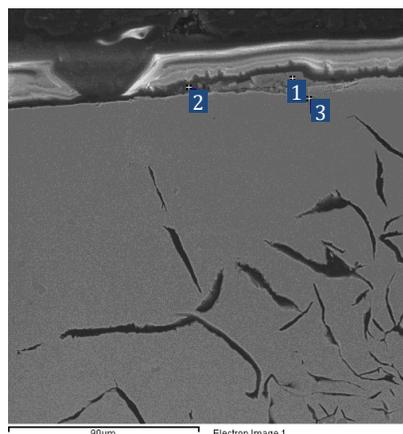
Spectrum No.	Element content, % wt.							
	C	O	Si	S	Cl	Ti	Mn	Fe
1	9.08	35.08	1.10	0.00	0.68	0.00	0.00	54.06
2	64.12	16.91	0.00	0.00	12.65	0.00	0.00	6.32
3	11.79	0.00	0.00	30.80	0.00	2.74	52.45	2.22

Fig. 6. An example specimen microstructure in transverse section. Note a layer of oxides adhered locally to the casting surface covered with a layer of paint with diversified thickness and flat face. Note also discontinuities of the paint coat

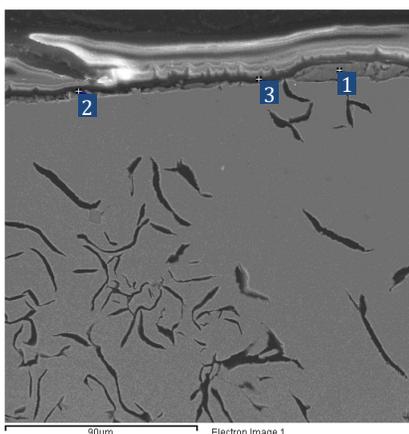
Spectrum No.	Element content, % wt.				
	C	O	Si	Cl	Fe
1	7.15	36.73	2.19	1.34	52.58
2	39.61	33.61	1.34	2.74	22.71
3	68.21	16.45	0.00	11.31	4.03

Fig. 5. An example specimen microstructure in transverse section. Note a layer of oxides adhered locally to the casting surface covered with a layer of paint and discontinuities of the paint coat

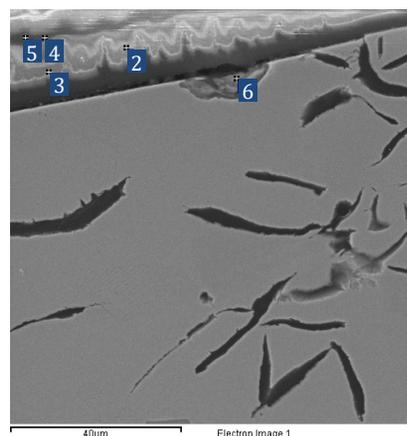
Spectrum No.	Element content, % wt.						
	C	O	Si	P	Cl	Ca	Fe
2	75.50	23.90	0.00	0.00	0.60	0.00	0.00
3	76.77	20.05	0.00	0.00	3.19	0.00	0.00
4	80.11	19.42	0.00	0.00	0.47	0.00	0.00
5	81.04	18.35	0.00	0.00	0.61	0.00	0.00
6	12.10	44.71	6.88	0.50	0.82	1.21	33.78

Fig. 7. An example specimen microstructure in transverse section. Note a corrosion pit on casting surface filled with oxides (point 6), covered with a layer of paint in which the first coat is characterised with low chlorine content (points 2 through 5)

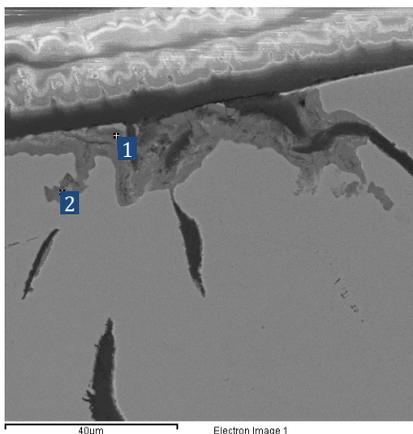
Spectrum No.	Element content, % wt.						
	C	O	Na	Si	P	Cl	Fe
1	7.95	40.50	0.66	6.65	0.56	1.00	42.67
2	5.46	37.79	1.16	5.06	0.00	0.89	49.64

Fig. 8. An example specimen microstructure in transverse section. Note a corrosion pit on casting surface filled with oxides at presence of chlorine (points 1 and 2), covered with paint coat
