EDWARD CEMPIEL¹, PIOTR STRZAŁKOWSKI¹, ROMAN ŚCIGAŁA^{1*},
IZABELA BRYT-NITARSKA²

ASSESSMENT OF DAMAGE CAUSES OF MONUMENTAL OBJECTS LOCATED IN MINING AREAS – CASE STUDY

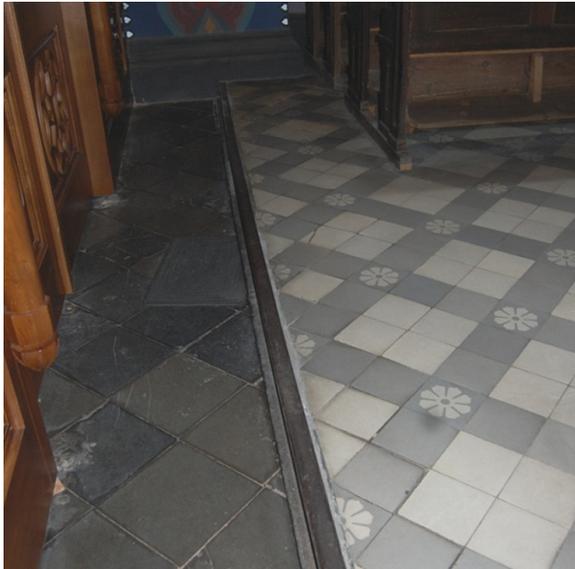
There is an approx. 15 cm threshold in the floor in the passage from the building of the Basilica to the original church. It is separated by a steel rail, which is slightly bulged, while the tiles in its vicinity are loose – Fig. 3.

Fig. 3. Threshold in the floor between the original church and the Basilica

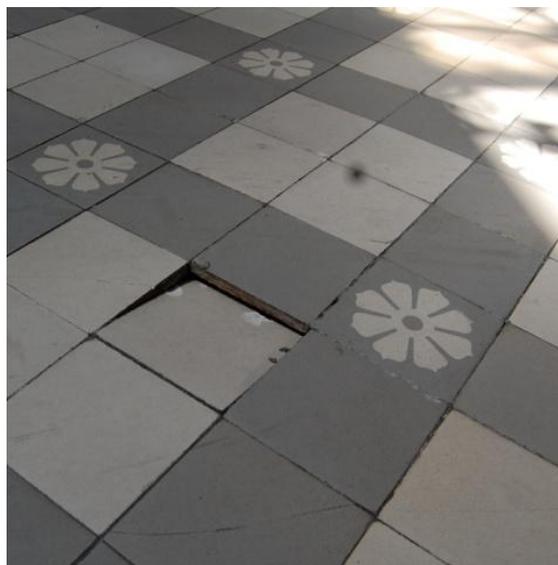
In 2006, numerous instances of damage to the ceramic tile floor were observed. The damage was concentrated mainly in the transverse aisles: in the eastern and western transepts as well as in the apse. The tiles were loosened, uplifted and cracked – Fig. 4.

Fig. 4. Damaged floor tiles

The floor laid within the main building of the church was not dilated, and as a result, it consists of a very large single horizontal plane. Additionally, the tiles were laid without grouting. It can be assumed that the problem with the uplifting of the ceramic floor tiles results from their instalment on the primary base using a layer of backfill material of an unknown origin and without gaps between the tiles. Such a structure is very sensitive to thermal and humidity changes resulting from the so-called normal conditions of use of the facility. When washing the floor, moisture might penetrate the foundation layer, and because the building is not heated and the foundation has been "closed" between "new and old" tiles, the draining of moisture is limited. In addition, frequent washing of the floor is performed in the autumn and winter periods, when the outside temperatures are low and sub-zero. Therefore, it can be assumed that in the closed foundation, the phenomenon of freezing and heaving of the backfill material might have occurred, which caused the floor to be elevated.

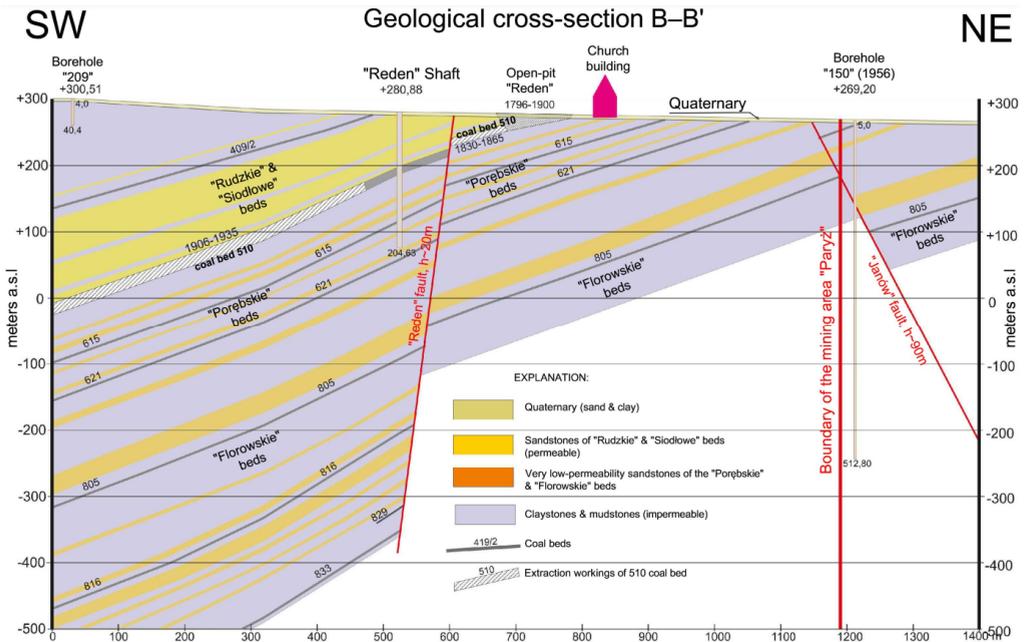
Fig. 5. Geological cross-section through the rock mass in the vicinity of the church

The building is located approximately 150 m away from the outcrop of this fault. The location of these faults against the position of the church building, together with the general rock-mass structure is shown in Fig. 5.

As can be seen from this sketch, the relatively great distance between the nearest located outcrops of faults and the direction of faults' dip "outside" the building location concludes that the presence of tectonic disturbances did not affect the church's technical condition.

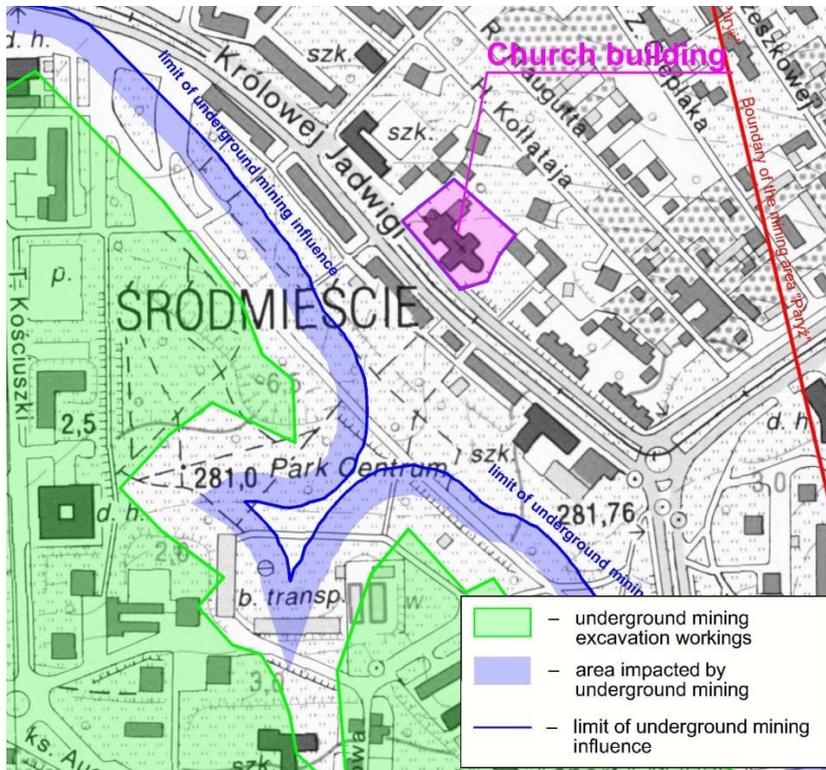
- Due to the lack of shallow underground mining workings in the direct vicinity of the church, there is no risk of sinkholes formation,
- The only factor that may cause linear discontinuous deformations are outcrops of the faults on the roof of Carboniferous beds due to possible fault slip. Fig. 5 shows the location of the faults in the area of the building. The large distance of the faults outcrops excludes the possibility that such deformations were formed.

Fig. 8. Calculated the limit of influence of the underground mining carried out in the past in the area of the church

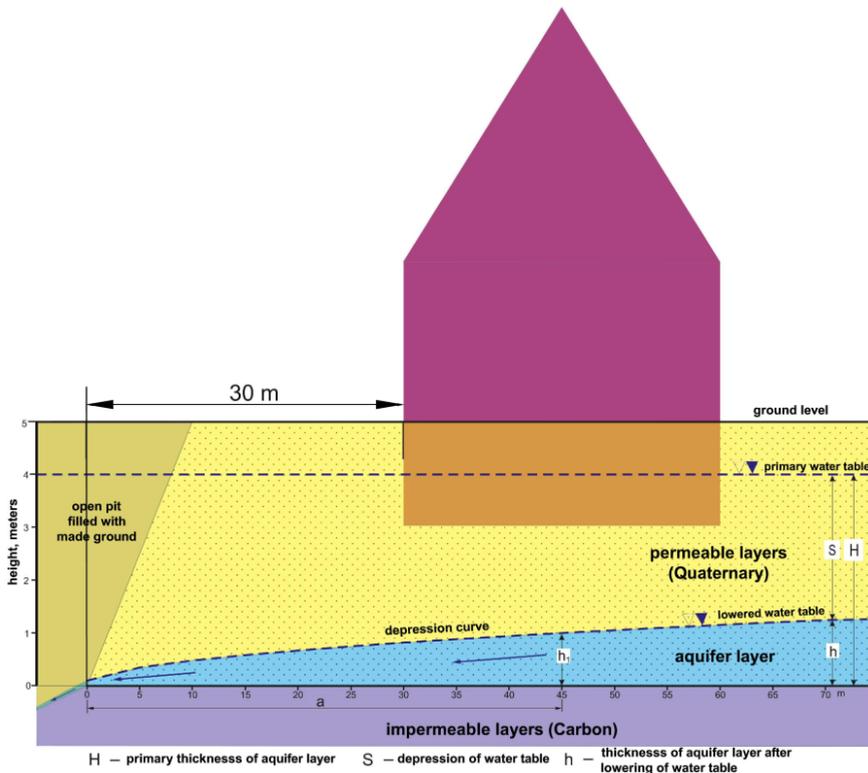
Fig. 9. The cone of depression in the Quaternary aquifer in the vicinity of the church

The hydraulic (head) gradient of the unconfined water table in the area of the cone of depression, in the area under the building, was assumed at the value of approximately $i = 0.008$ on the east side of the building (at distance $x = 60$ m) to approximately $i = 0.016$ on the west side (at distance $x = 30$ m).

The results allow us to exclude the possibility of the occurrence of mechanical suffosion in the sandy soils of the Quaternary layers as a result of the formation of the cone of depression due to mine drainage in the Quaternary aquifer layer and water filtration on the cone of depression in the direction of abandoned workings of the 510 coal bed. In conclusion, it should be stated that the existing damage to the church building cannot be associated with mining works of the former "P" mine and with the currently ongoing partial flooding of the mine workings, including changes in water damming in the abandoned workings.

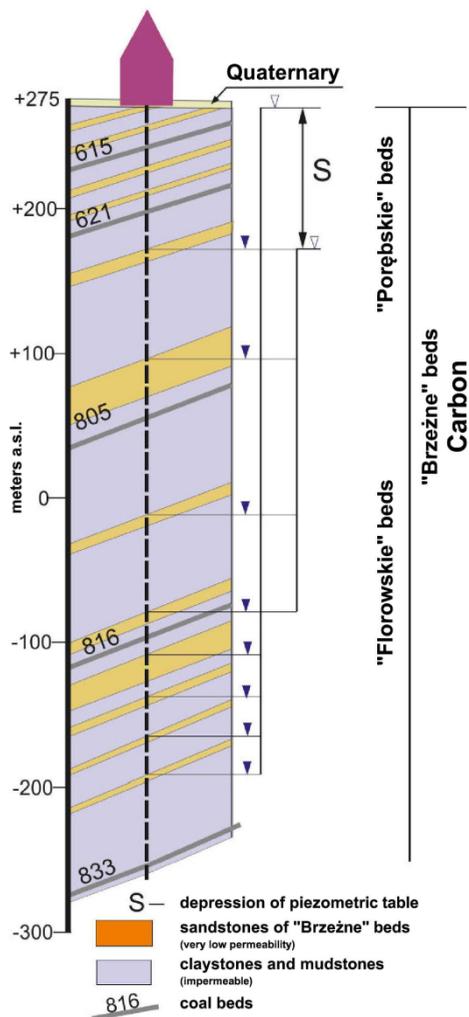
The maximum possible depression of the potentiometric surface of the aquiferous layers of Carboniferous sandstones, which occur at the foundation of the building, was estimated at 100 m (Fig. 10).

Fig. 10. Calculation scheme for ground subsidence caused by lowering of the hydrostatic pressure of Carboniferous sandstones

Taking into account the value of the calculated subsidence of the area (approximately 8.4 mm), the relation between the existing building damage and changes in hydrostatic pressures in the Carboniferous rock mass should be excluded.
