# Industrial floor faults caused by volume changes in concrete and subsoil: case study

# Radim Cajka<sup>1</sup>, Jana Vaskova<sup>2</sup>, Martina Smirakova<sup>3</sup>, Kamil Burkovic<sup>4</sup>, Zdenka Neuwirthova<sup>5</sup>

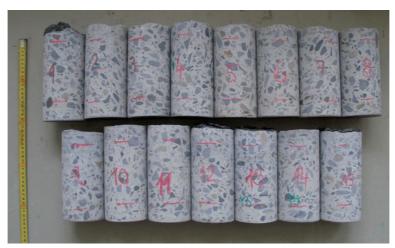
Fig. 5. Laboratory samples from the industrial floor of the production hall in Ostrava-Vítkovice

of concrete is 37.15 MPa. The resulting characteristic (cubic) compressive strength of concrete is 30.23 MPa, the concrete corresponds to strength class C 25/30.
