# The effect of long-term service at elevated temperatures on structure and mechanical properties of Cr-Mo-V steel

**Design/methodology/approach:** Examinations were conducted on 273 mm diameter, 32 mm wall thickness tube made of 13HMF (14MoV6-3) steel. The tube was a segment of stem pipeline used in power plant at 540°C. The service time is 168,000 hours. Microstructure of the material has been examined with the use of light optical microscopy and scanning electron microscopy (SEM). The energy dispersive X-ray spectrometry (EDS) analysis was used for phase chemical composition identification. Transmission electron microscopy (TEM) of thin foils was used for carbides structure identification. The mechanical properties of the tube material were evaluated in static tensile tests at room temperature, hardness tests and impact Charpy U tests.

**Keywords:** Creep-resistance; Structure degradation; Cr-Mo-V steel; Steam pipeline

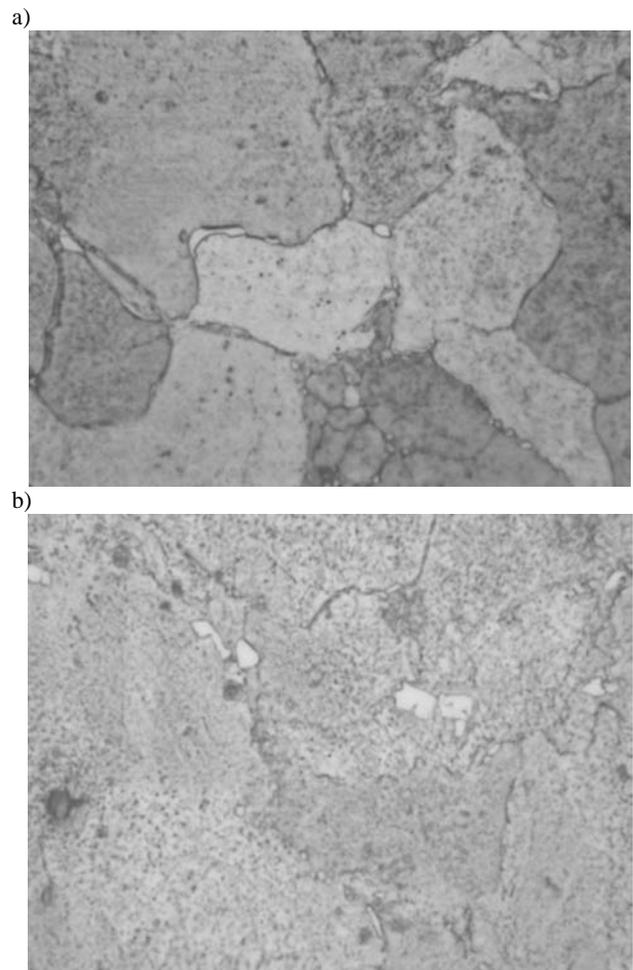
Fig. 1. Microstructure of 13HMF steel tube  $\varnothing 273 \times 32$  mm, Magn. 1000x

The structure of the tube material has an advanced degree of degradation. On Fig. 1 it can be seen separate coagulated cementite particles and carbides at the grain boundaries of ferrite and bainite areas. Visible are large single precipitates and precipitates occurring in the form of strings deployed along the grain borders. Assessment of structure degradation according to the criteria [10] corresponds to the model of SIII. There were no decohesion changes in the tube steel microstructure.

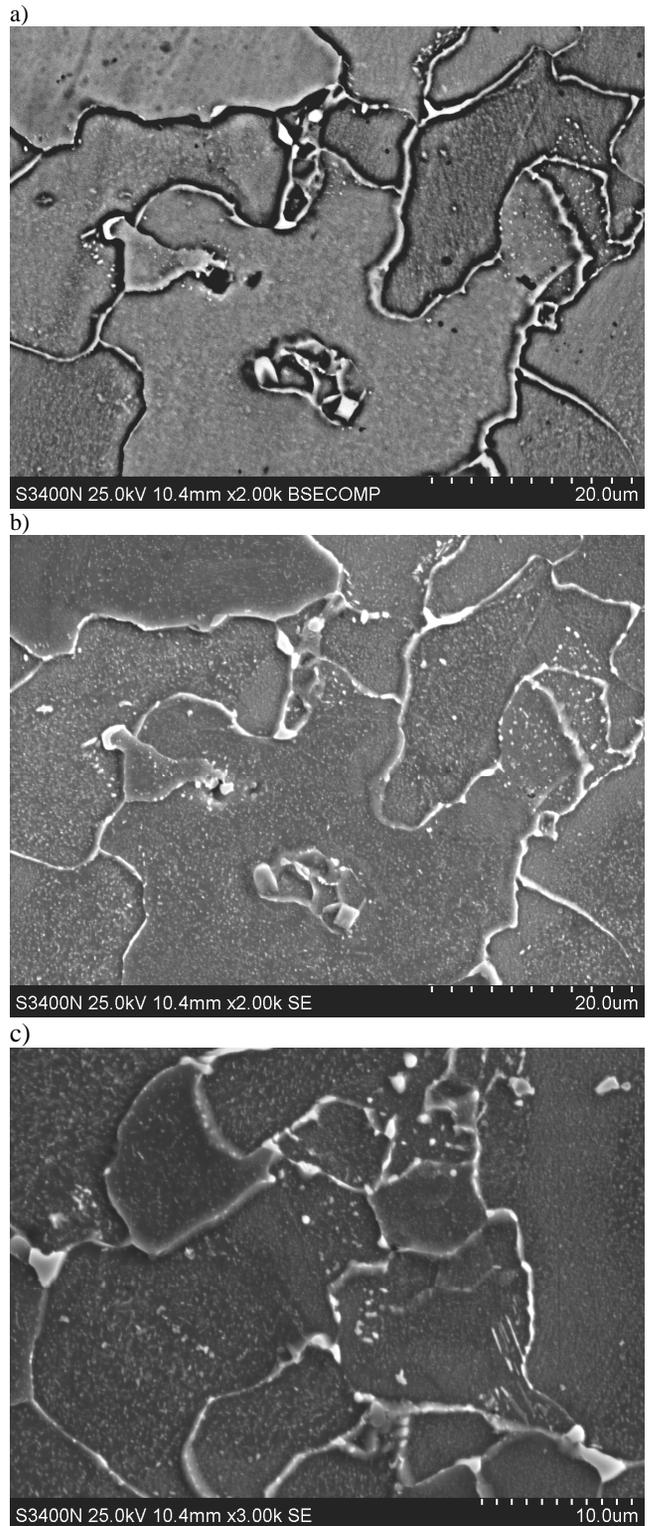
Fig. 2. Carbides morphology in 13HMF steel, tube Ø 273 × 32 mm. Observations performed at metallographical samples SEM, detector: a) BSE, b), c) SE

Morphology of carbides observed on metallographic samples is shown in Fig. 2. Many small carbides are visible - dispersed inside the degraded bainite grains and relatively large carbides at grain boundaries, which often form a continuous net.

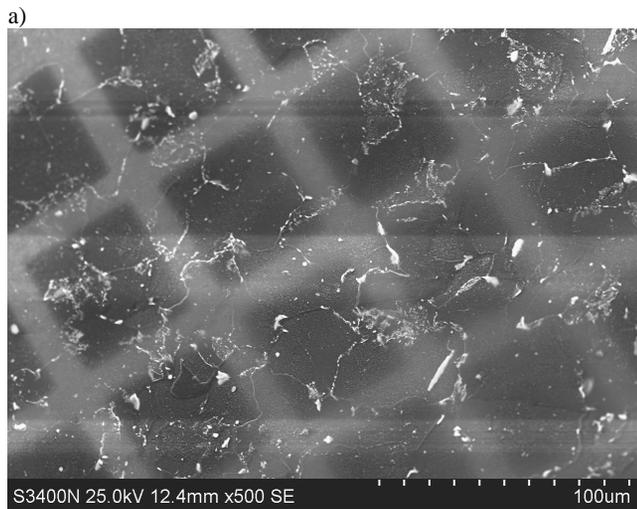
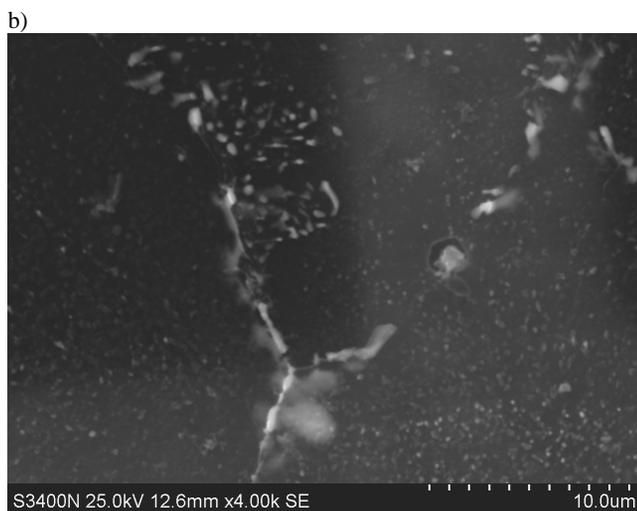
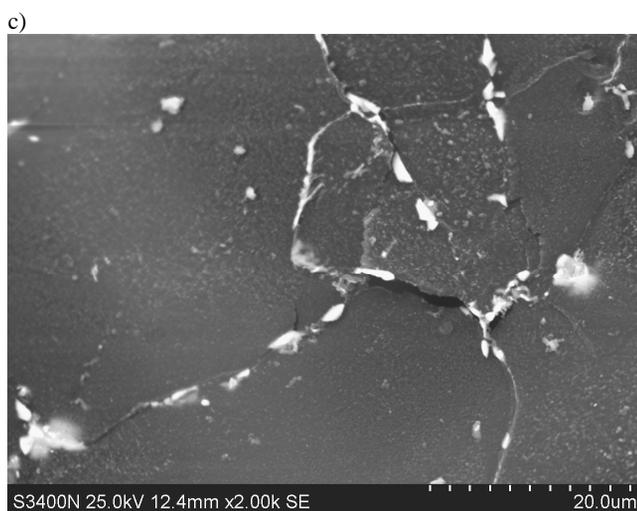
Fig. 3. Carbides morphology in 13HMF steel, tube  $\varnothing 273 \times 32$  mm. Extraction replica, SEM, detector SE

Carbides morphology disclosed on a replica is shown in Figs. 3,4.

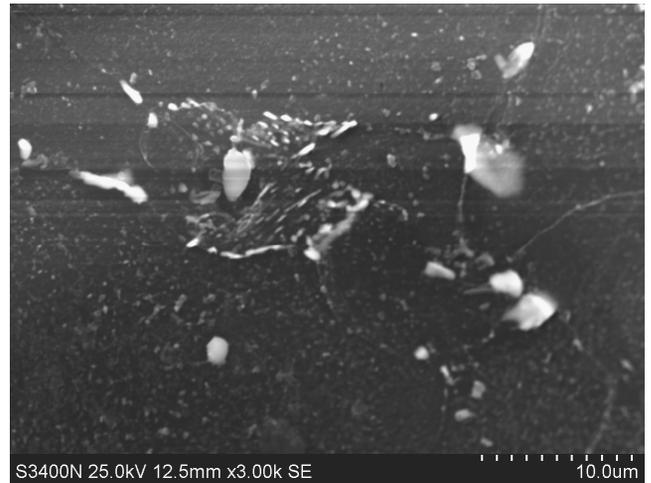
Fig. 4. Carbides morphology in 13HMF steel microstructure, tube  $\varnothing 273 \times 32$  mm. Extraction replica, SEM, detector SE

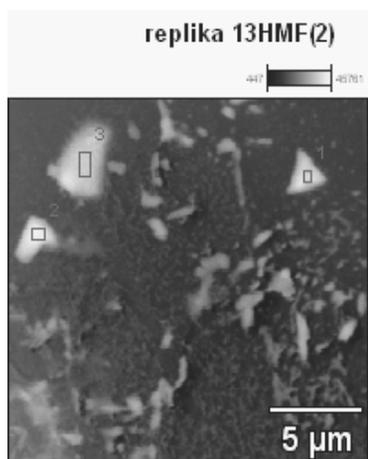
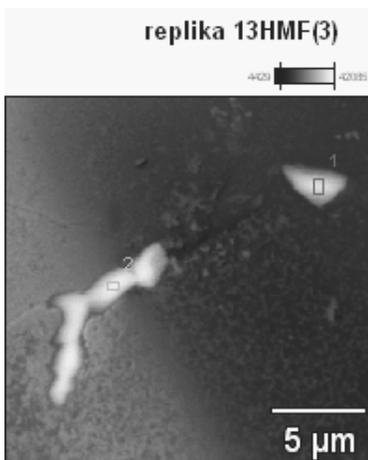
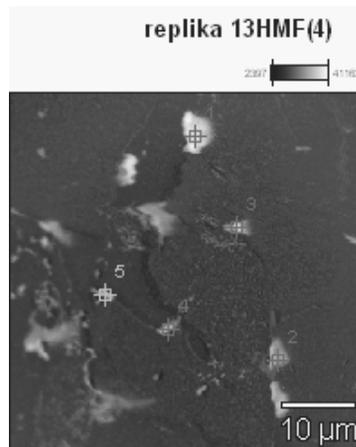
Weight %					
Point	V-K	Cr-K	Mn-K	Fe-K	Mo-L
pt1	0.67	7.61	6.94	70.18	14.60
pt2	1.09	7.75	7.34	70.39	13.43
pt3	1.50	7.81	8.00	73.00	9.68

Weight %					
Point	V-K	Cr-K	Mn-K	Fe-K	Mo-L
pt1	1.14	7.09	8.25	68.51	15.02
pt2	0.80	7.24	7.58	71.15	13.24

Weight %					
Point	V-K	Cr-K	Mn-K	Fe-K	Mo-L
pt1	1.65	7.07	7.29	69.83	14.15
pt2	2.20	7.43	7.53	69.38	13.45
pt3	1.47	7.12	7.64	69.07	14.69
pt4	1.28	6.81	8.43	67.67	15.81
pt5	1.56	7.50	7.56	65.60	17.78

Fig. 5. EDS chemical microanalysis and morphology of carbides in 13HMF steel, tube  $\varnothing 273 \times 32$  mm. Extraction replica, SEM, detector SE

Example results of chemical composition investigations of carbides are presented in Fig. 5. It was found that carbide content by weight is about: 14% Mo, 8% Mn, 7% Cr and 1% V. It should be noted that the EDS analysis of low volume carbide precipitates is a qualitative analysis and does not give the exact chemical composition of the phase only by informing the elements are present.

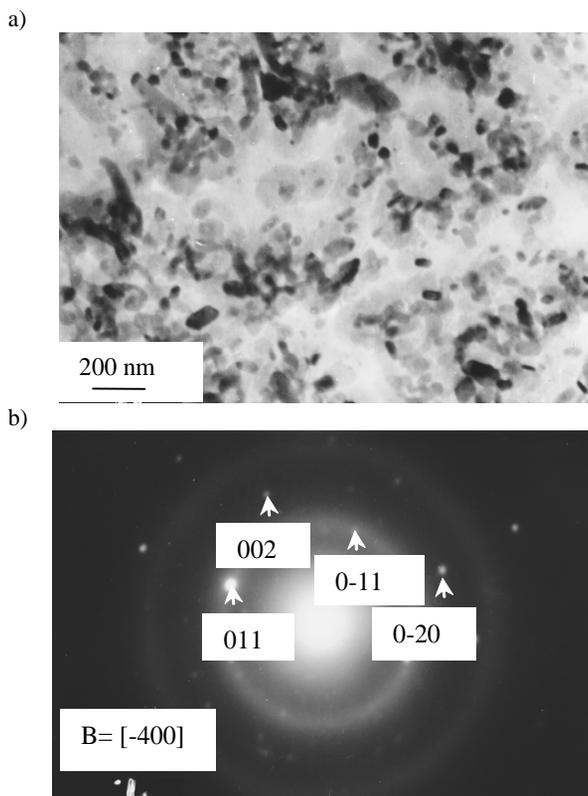
Fig. 5. a) Dispersed MC precipitates, TEM image b) Diffraction pattern of MC precipitates

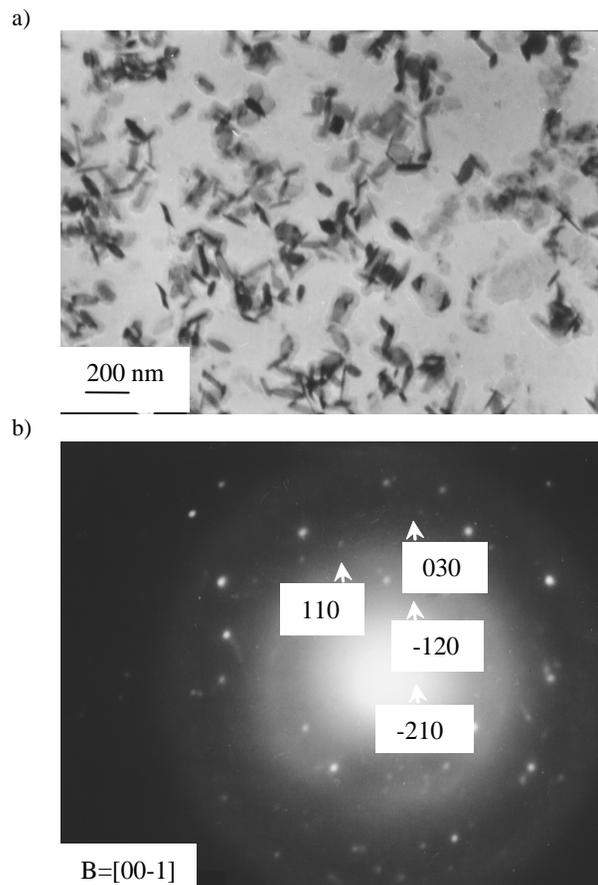
Fig. 6. a) Dispersed  $M_2C$  precipitates, TEM image b) Diffraction pattern of  $M_2C$  precipitates

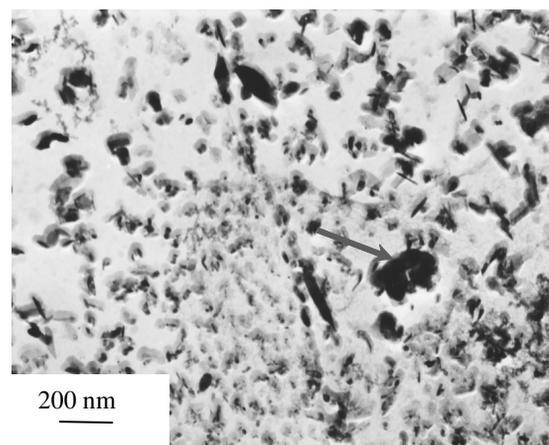
Fig. 7. The diverse morphology of the precipitates. Arrow marked the precipitation where the diffraction was performed

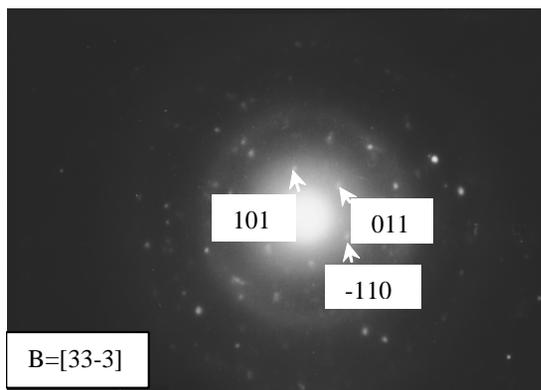
Fig. 8. Diffraction pattern of particle shown by arrow in Fig. 7,  $M_{23}C_6$  precipitate

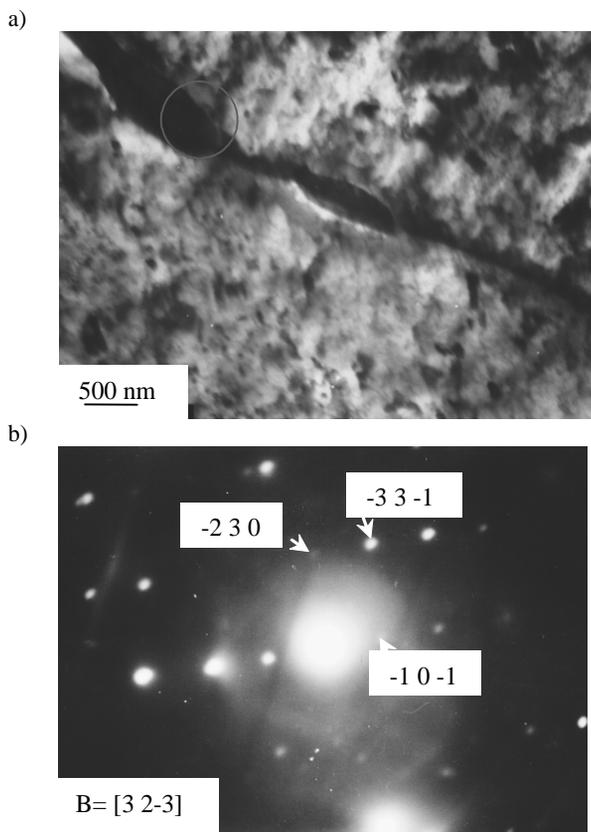
Fig. 9. a) Dispersed  $M_7C_3$  precipitates, TEM image b) Diffraction pattern of  $M_7C_3$  precipitates
