LOSING THE GROUND BENEATH YOUR FEET

Any insufficiently understood dynamic geological process can be potentially dangerous.

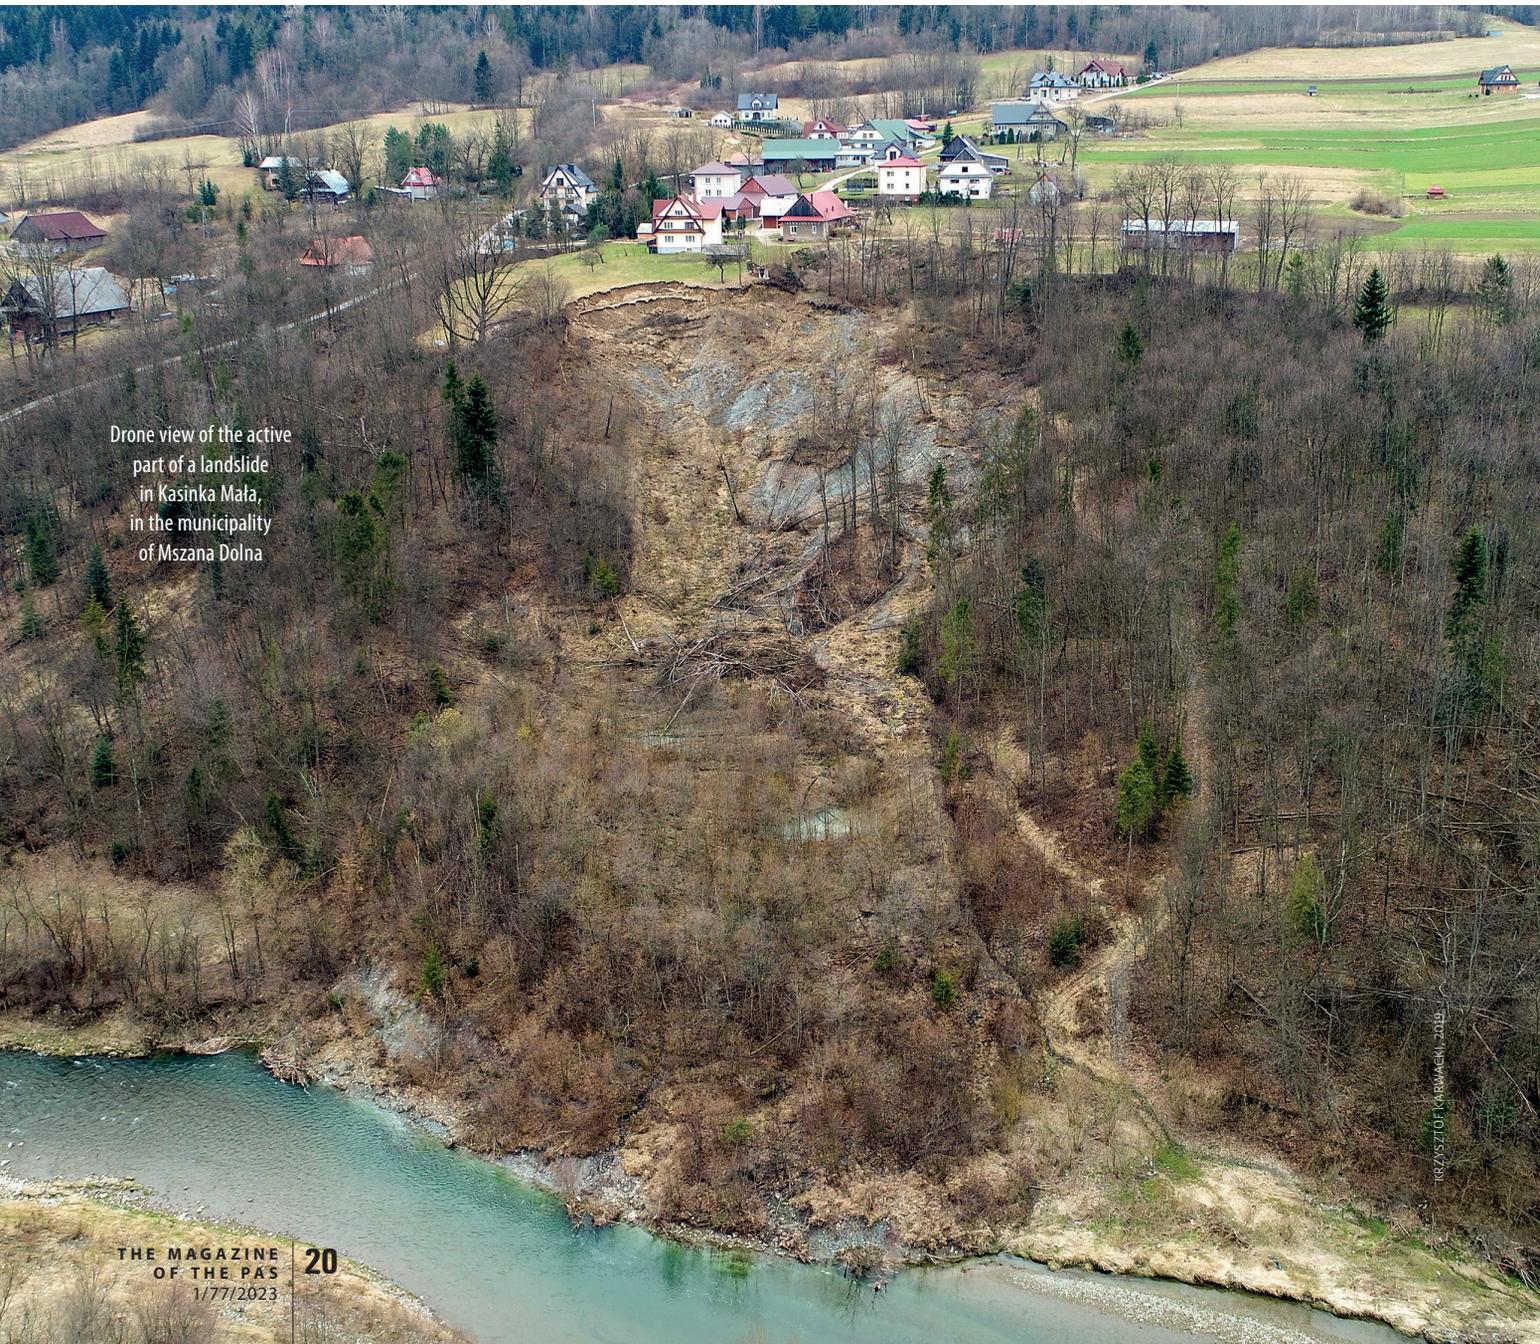
Drone view of the active part of a landslide in Kasinka Mała, in the municipality of Mszana Dolna

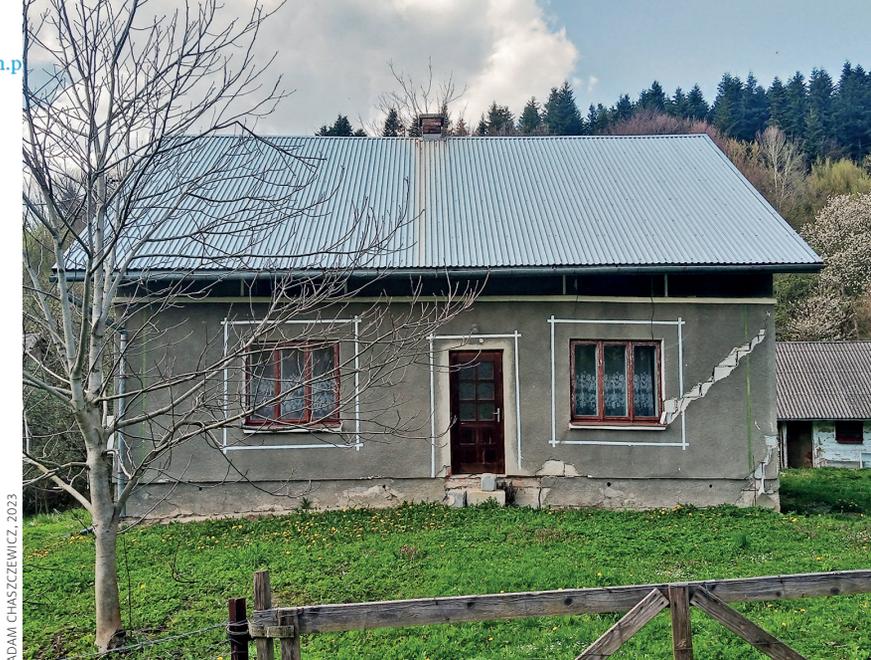
Cracks forming in the walls of a residential building built on landslide colluvium – Dąbrowka Starzeńska, Dynów municipality

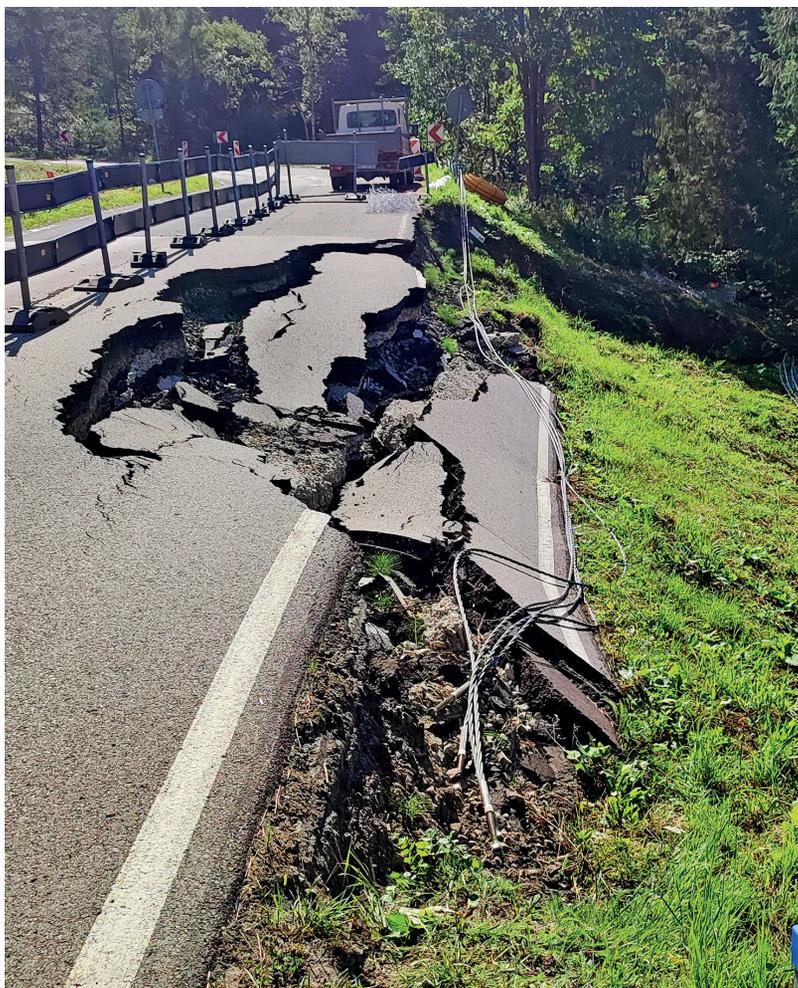
Landslide-damaged fragment of road between Wetlina and Brzegi Górne

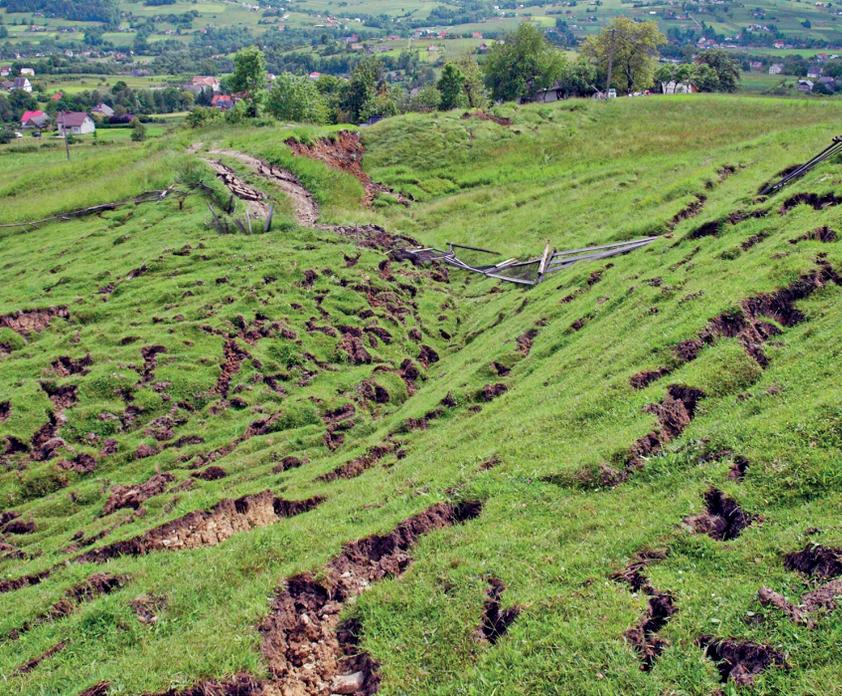
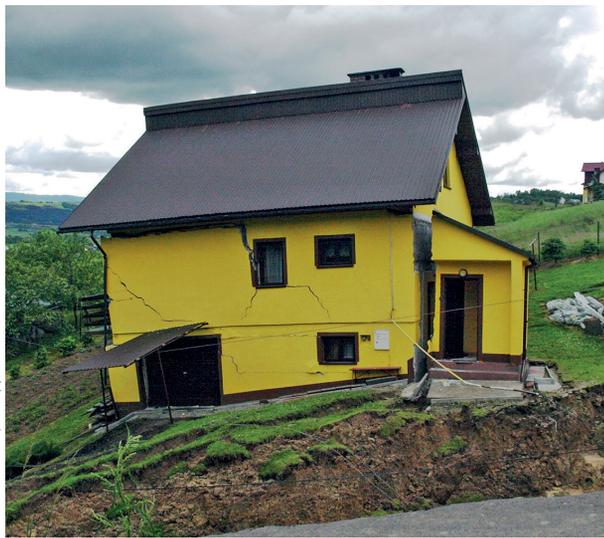
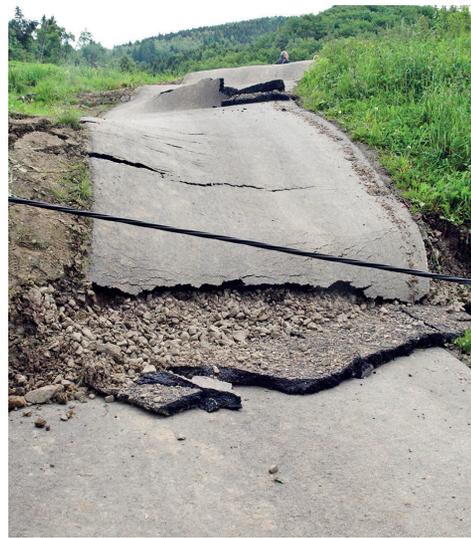
Devastation caused by a landslide in Kłodne, Limanowa municipality
