EDWARD CEMPIEL¹, PIOTR STRZAŁKOWSKI¹, ROMAN ŚCIGAŁA^{1*},
IZABELA BRYT-NITARSKA²

ASSESSMENT OF DAMAGE CAUSES OF MONUMENTAL OBJECTS LOCATED IN MINING AREAS – CASE STUDY

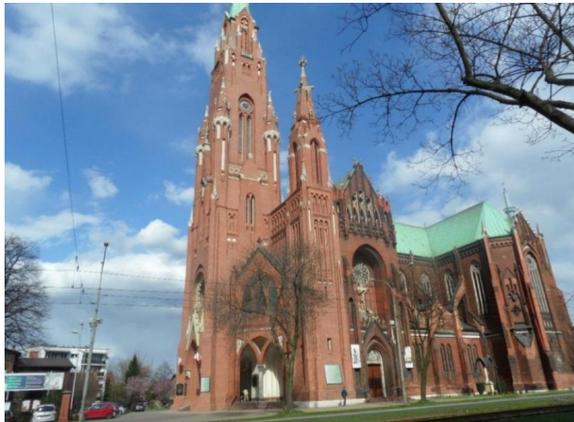
Fig. 1. General view of the church building

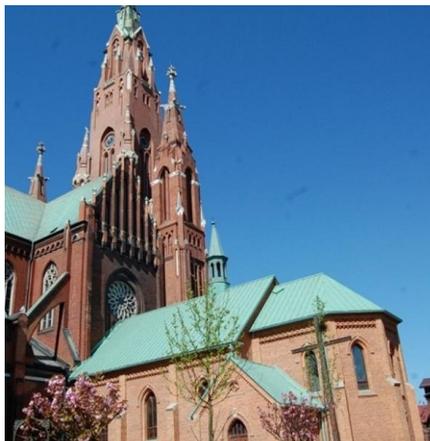
Fig. 2. The original church of Saint Alexander together with the adjacent Basilica object

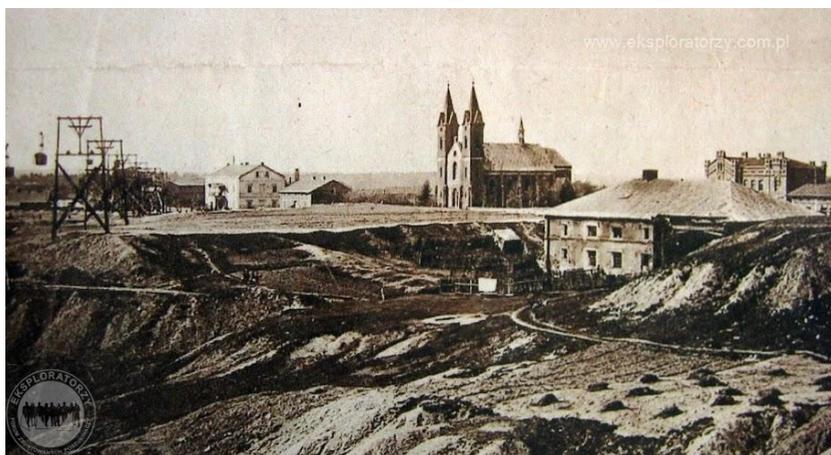
In the direct neighbourhood of the building, open pit mining of the 510 coal bed at the outcrop was conducted in the past. The boundaries of mining extraction were marked with the outcrop located approximately 30 m away from the building – Fig. 6.

Fig. 6. General view of the "Reden" open pit of the 510 coal bed. This photograph was taken in the early 20th century. (source: <http://www.eksploratorzy.com.pl>)

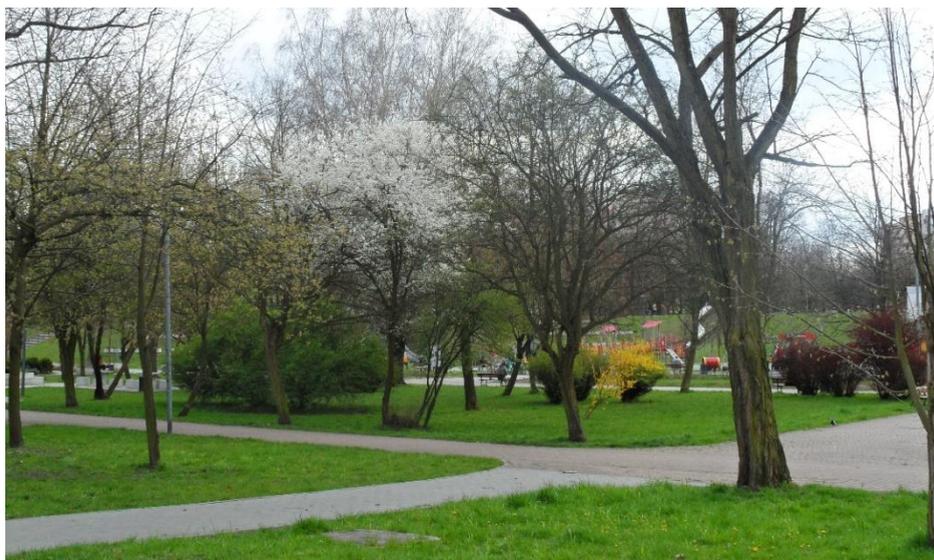
Open pit mining was conducted between 1863 and 1905. According to the archival maps, underground mining to the south of the open pit was conducted until 1918. Whereas near the church, underground mining was conducted to the west of the open pit and north of the "Reden" shaft. The last extraction in the vicinity of the building (to the south of it) was conducted in the 1930s. It should be noted that at that time, the shortwall mining method was applied for underground mining. According to the mining maps, the open pit was then used to drive roadways accessing coal beds and preparing for underground extraction. The liquidation of the open pits commenced at the end of 1945 using slag from the nearby still plant. The area of the former open pit was transformed into a 50 ha park, which exists today – Fig. 7.

Fig. 7. General view of the park in the former open-pit mine area
