DAMAGE DIAGNOSTICS OF TURBINE BLADES

The paper presents the most frequently encountered types and mechanism of damage of turbines' flow elements. The methods used nowadays for diagnosis of the damage are presented. A new possibility of localisation of damaged areas of turbine blades based upon the analysis of isotherm layout is proposed.

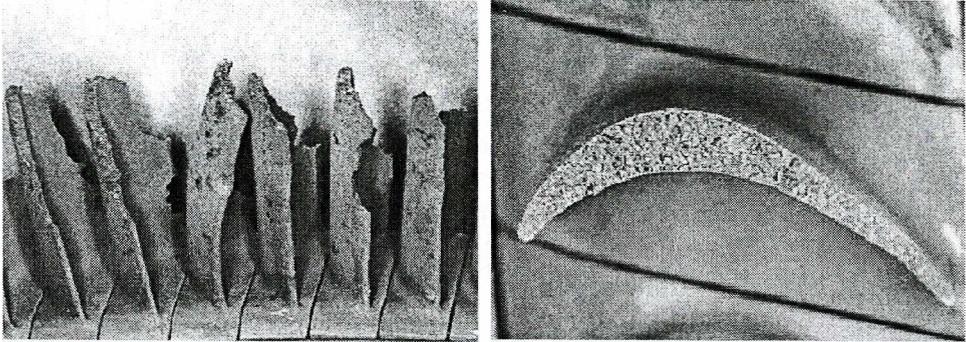
Fig. 1. Damage of the turbine blades of low-pressure section (by [1])

Vibrations are the main and direct causes of damage of the turbine blades. Vibrations of the blades are the source of the destroying damage process giving characteristic low-grain-type fracture. Sharp endings of the blade edges are the places where the greatest stresses occur in the case of bending. Most frequently, the fatigue fractures begin in these areas. Other sources of fatigue fracture can be e.g. material imperfections, scratch or indentation of material of the blade. Other causes, which can destroy the blade, are excessive centrifugal forces appearing due to overloads – they can cause deformation and tearing of the blades with characteristic – high-grain-type fracture. Fig.1 depicts the damaged blades of the first stage of the low-pressure turbine of turbo propeller motor caused by rapid overload due to damage of blades of high-pressure section of the turbine [1].

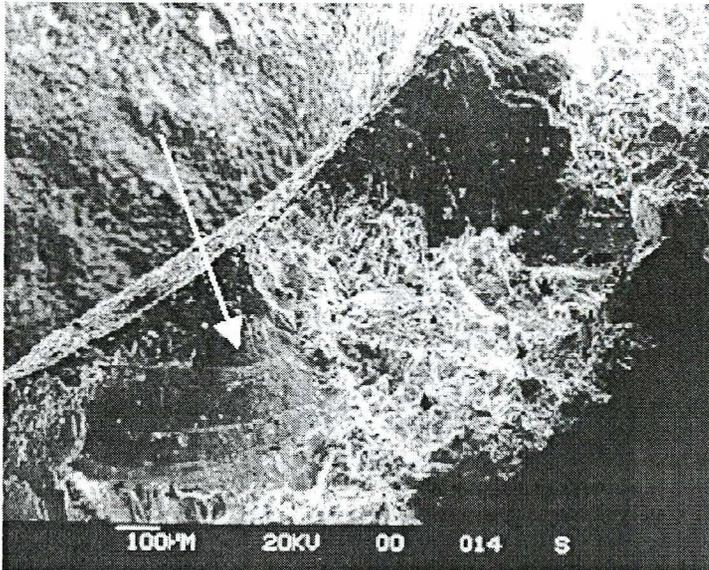
Fig. 2. Microscope photo of the fatigue fracture in the high-pressure turbine blade (by [1])

In Fig. 2, propagation of fatigue crack through the material of the blade can be clearly seen [1]. During vibrations, the opening and closing of the crack take place; these phenomena are simultaneous with crushing of the fracture planes. The increase of the number of vibrations leads to wear phenomenon which, in turn, causes that low-grain structure is obtained moreover, the smoother the surface, the longer the degradation process.

The cause of fatigue failures is usually the phenomenon of resonance between proper vibrations and forced vibrations. Despite the fact that the contemporary calculation methods of determination of proper-vibrations are associated with adequate laboratory experiments, the obtained outcomes can still be disturbed, and the occurrence of resonance is possible. In the case when the resonance vibrations take place, the stresses in a blade increase rapidly, what can cause breakage of the blade, and the fatigue fracture is characteristic in this case. The fatigue fracture front passes to the consecutive weak places of the material, the so-called rest lines that are presented in Fig. 2.

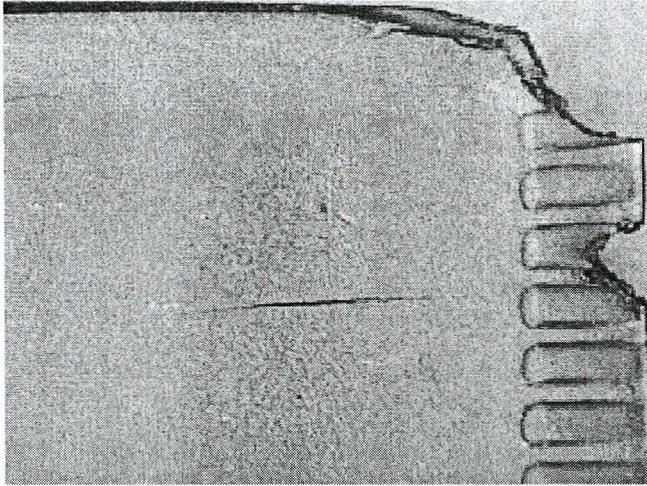
Fig. 3. Radial crack in the concave part of the high-pressure turbine blade (see [1])

Periodicity of the forces acting on the impeller blades can also be the result of the existence of the technological deviations of dimensions of the impeller blades. Taking into account the variability of the flow rate of the medium in particular vents and the variability of velocity and pressure of the gas by the outlet of the vents, one can state that even small deviation of dimensions of the stator blade can cause vibration of working blades and in consequence nucleating of crack (Fig. 3).

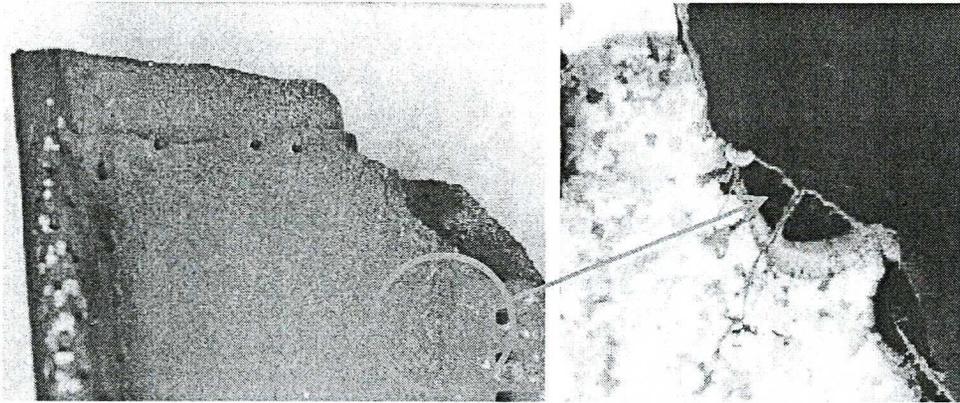
Fig. 4. The failures of the blade which have originated in the repair weld zone

Improper performance of maintenance works can sometimes be the cause of fatigue breakdown. In the figures underneath, the blades' failures are presented. Those were caused due to accumulation of thermal and mechanical fatigue damage originated in the zone of repair weld made on the blade, because the alloy used there was of slightly less strength than that of the material of the blade [1].

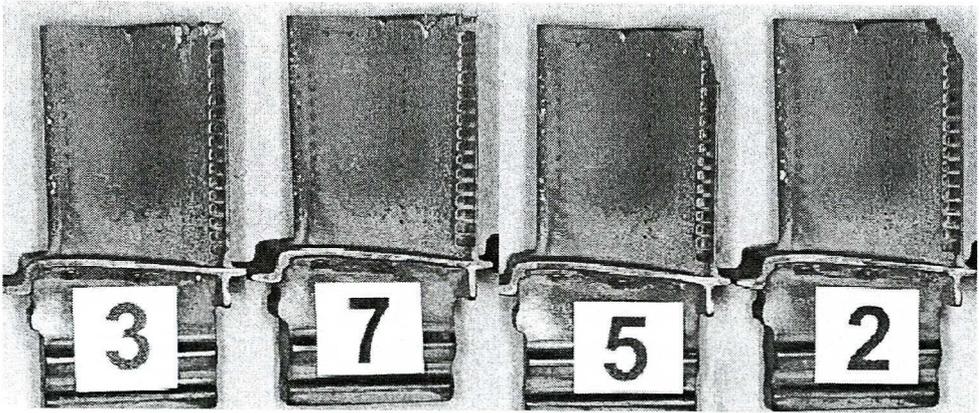
Fig. 5. Failures caused by thermal fatigue in the high-pressure turbine blades (see [1])

The photos inserted hereunder illustrate the size and the range of the failures caused by thermal fatigue in the turbine blades of the high-pressure section. These failures were the cause of the passenger jet engine damage [1] – quoted at the beginning of this paper.

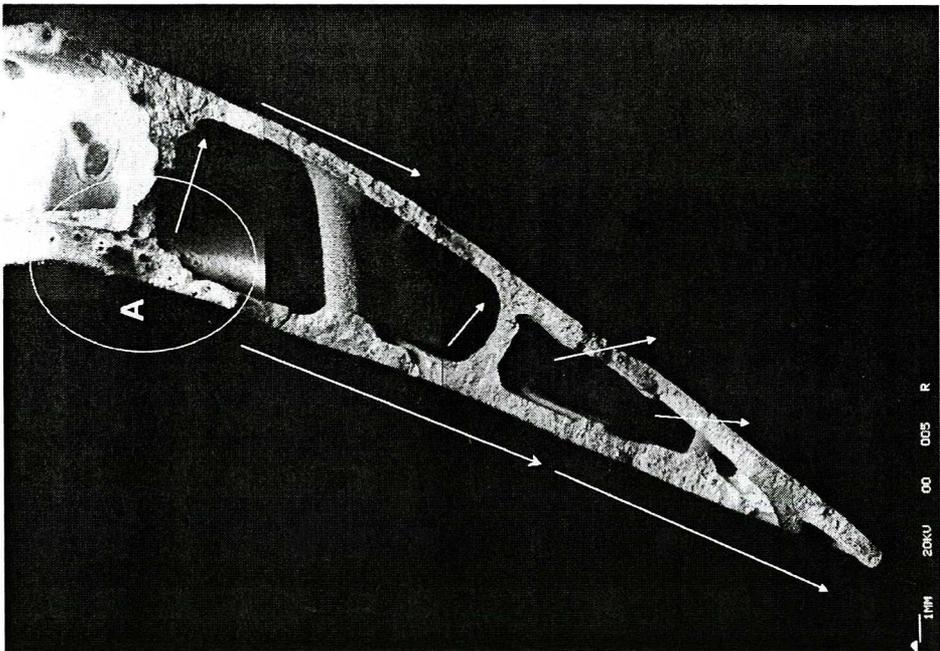
Fig. 6. Microscope image of the region of cracks caused by thermal fatigue (by [1])

Fig. 6 presents a microscope image of the cross-section of one of the damaged blades. The area denoted in the figure by capital letter A shows the region where the cracks caused by thermal fatigue arise, and the arrows show the predominant direction of crack propagation.

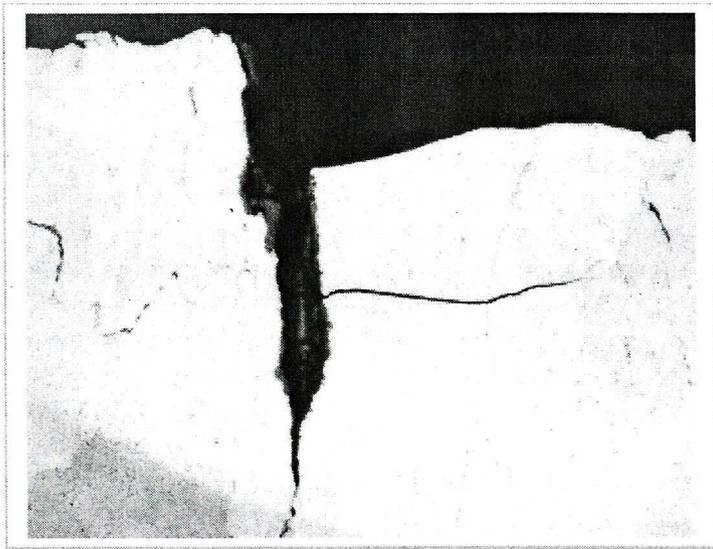
Fig. 7. Examples of inter-crystal and intra-crystal mechanism of fracture (by [1])

Both of the described mechanisms can occur simultaneously, what is presented in the photo in Fig. 7. The vertical crack passes along the grains' boundaries and the horizontal one is caused by an intra-crystal crack.

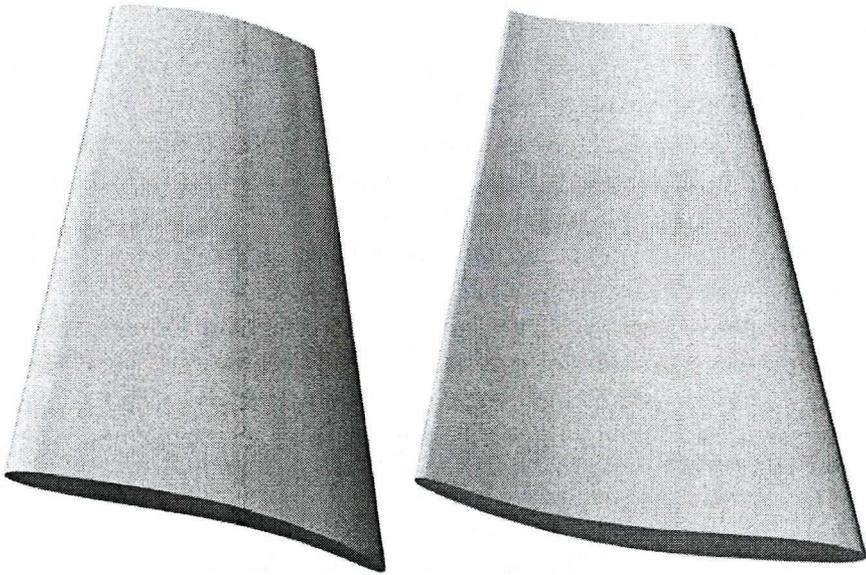
Fig. 8. The turbine blade used for numerical simulations

upon the analysis of isotherm layout obtained as the output of the software package ANSYS-5.7. Similar thermographs can be obtained using thermovision appliances. The exemplary blade had the following characteristics and parameters: it was made of duralumin, density $\rho = 2700 \text{ kg/m}^3$, coefficient of thermal conductivity $k^* = 215 \text{ W/m}^\circ\text{K}$ for the undamaged area and $k = 21.5 \text{ W/m}^\circ\text{K}$ for the damaged zone. The blade was subjected to the thermal loading by means of a point source of heat at constant temperature 400°K . The initial temperature of the blade was equal to 293°K . The shape of the blade is presented in Fig. 8.

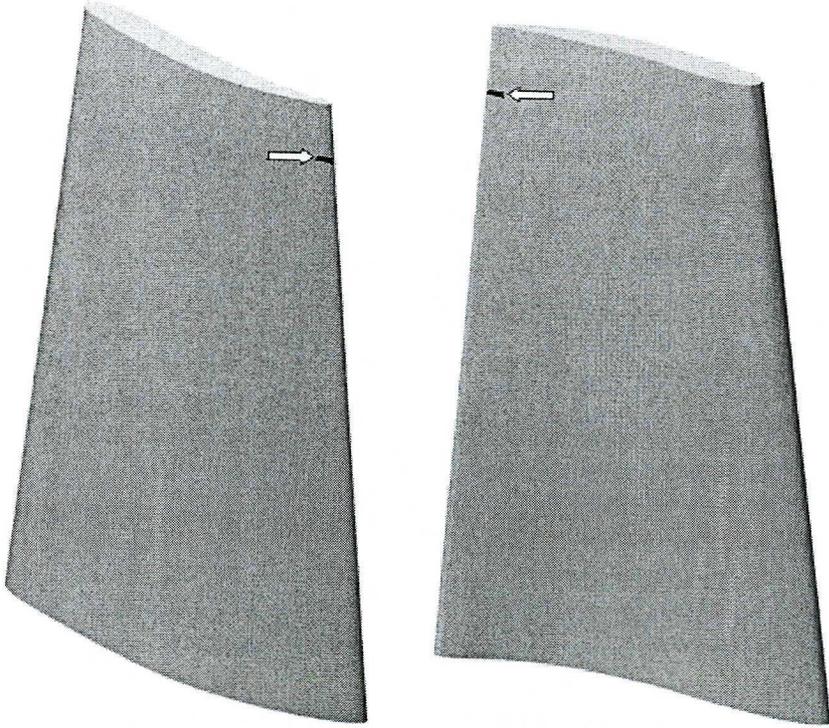
Fig. 9. The blade with the marked damaged regions in the concave and convex parts

The damage was simulated in the upper, boundary part of the blade, on the concave and convex surfaces in the regions marked in Fig. 9.

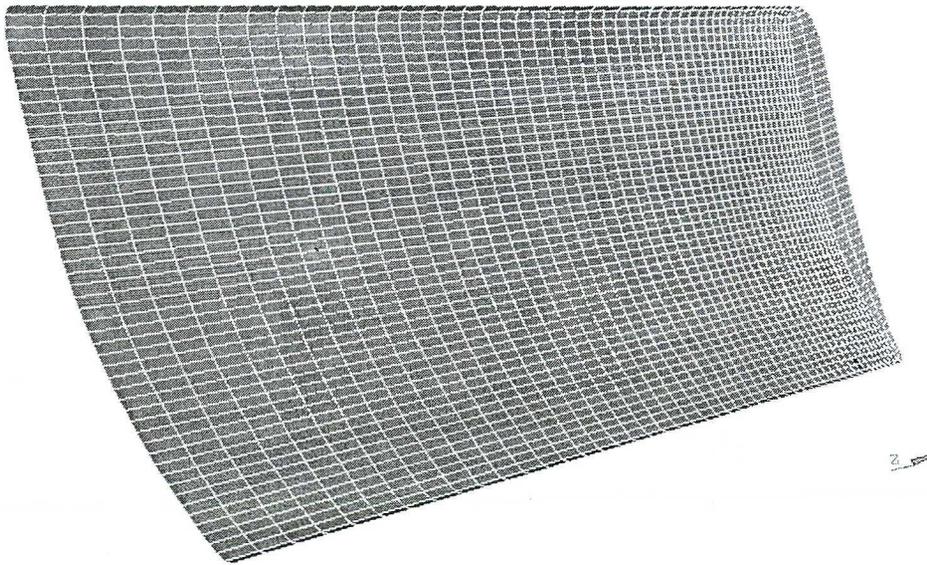
Fig. 10. The division of the blade into finite elements – view of convex part

The division of the blade into the eight-node finite elements 3D – SOLID 70 type is presented in Fig. 10 and Fig. 11.

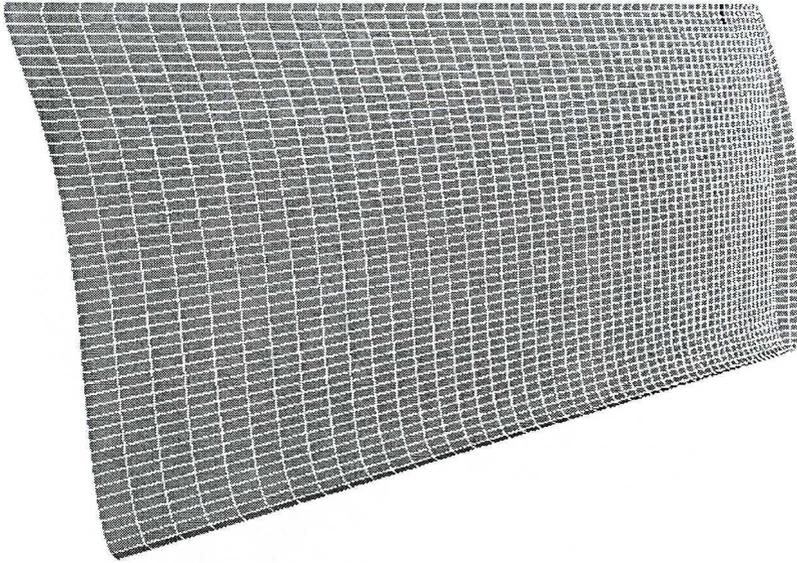
Fig. 11. The division of the blade into finite elements – view of concave part

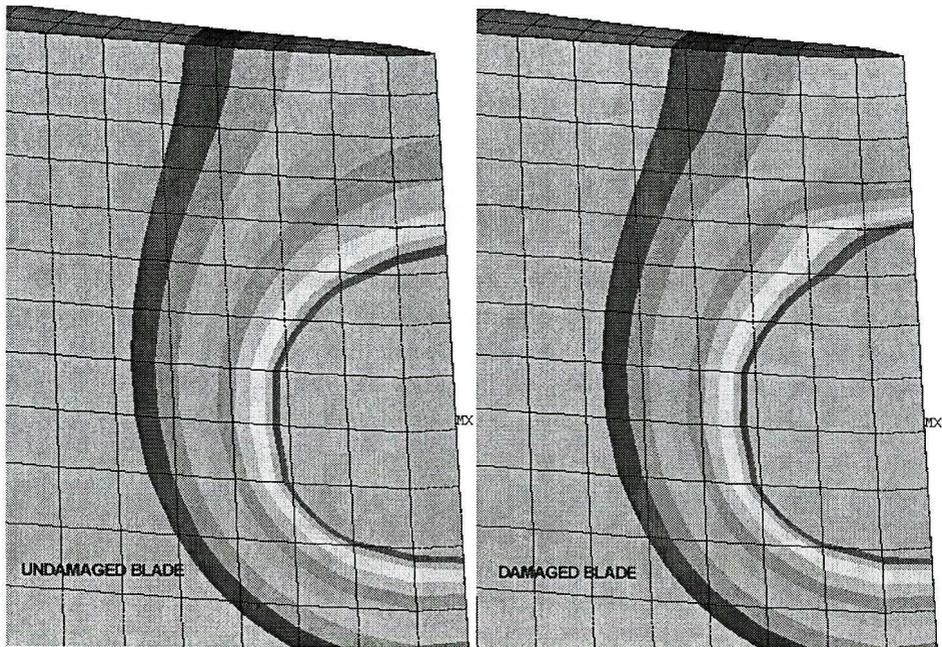
Fig. 12. The distribution of isotherms in the damaged zone of the blade, in comparison to the undamaged one

As the result of the performed numerical investigations, we obtain the hereunder-presented images of isotherms on the convex part of the blade. They are presented the isolines (Fig. 12) and (Fig. 13).

It can be seen in thermograms obtained upon the numerical calculations that there are evident disturbances of the temperature distribution in the damaged zone in comparison to the undamaged blade. This deformation of isotherm layout allows for precise localisation of damaged zone in the blade.

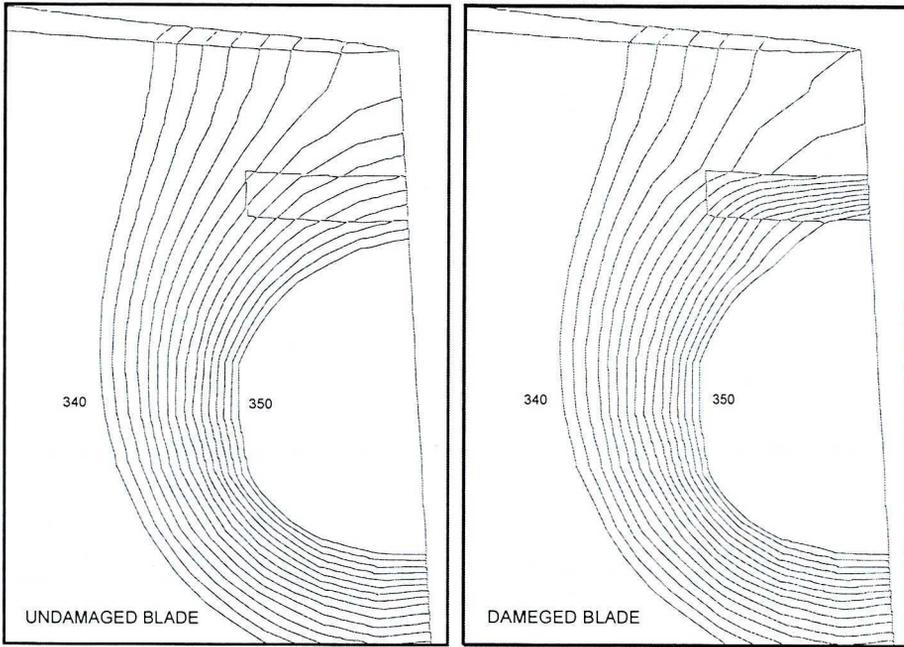
Fig. 13. The distribution of isotherms in the damaged zone of the blade, convex part

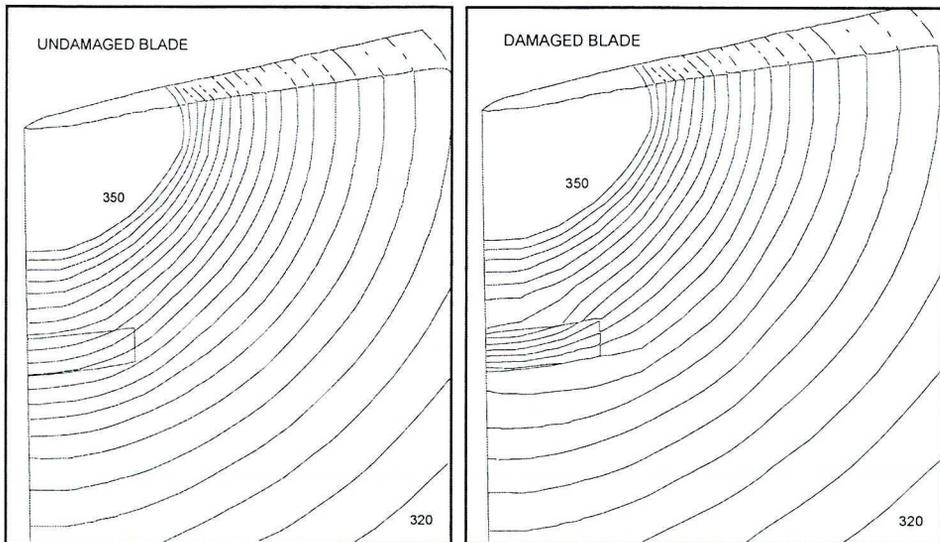
The distribution of isotherms in the damaged zone on the concave surface of the blade is presented in Fig. 14.

Fig. 14. The distribution of isotherms in the damaged zone of the blade, concave part
