DOI: <https://doi.org/10.24425/amm.2024.147783>HONG-PYO KIM^{1*}, JONG-YEON LEE¹, SUNG-HWAN CHO¹, MIN-JAE CHOI¹, SUNG-WOO KIM¹,
HYUNG-HA JIN¹, DONG-JIN KIM¹, SEOUNG-SIK HWANG¹, YUN-SOO LIM¹**FRACTOGRAPHY OF STRESS CORROSION CRACKING OF 20% COLD WORKED TYPE 304 H STAINLESS STEEL
CONTAINING δ -FERRITE IN OXIDIZING PRIMARY WATER**

Fractography of stress corrosion cracking (SCC) of 20% cold worked Type 304 H stainless steel containing δ -ferrite was studied using a compact tension (CT) specimen in oxidizing primary water with a scanning electron microscope (SEM) and electron back scattered diffraction (EBSD). The stress corrosion crack propagated mostly in transgranular stress corrosion cracking (TGSCC) mode and sometimes in intergranular stress corrosion cracking (IGSCC) mode. TGSCC paths were along the $\{111\}$ plane with both high resolved shear stress and high resolved tensile stress. IGSCC preferentially propagated along the grain boundary perpendicular to the loading axis. The findings in this work suggest that TGSCC proceeds through formation of a weakening zone at the head of the crack tip by interaction of slip and corrosion and then cracking of the weakened zone by tensile

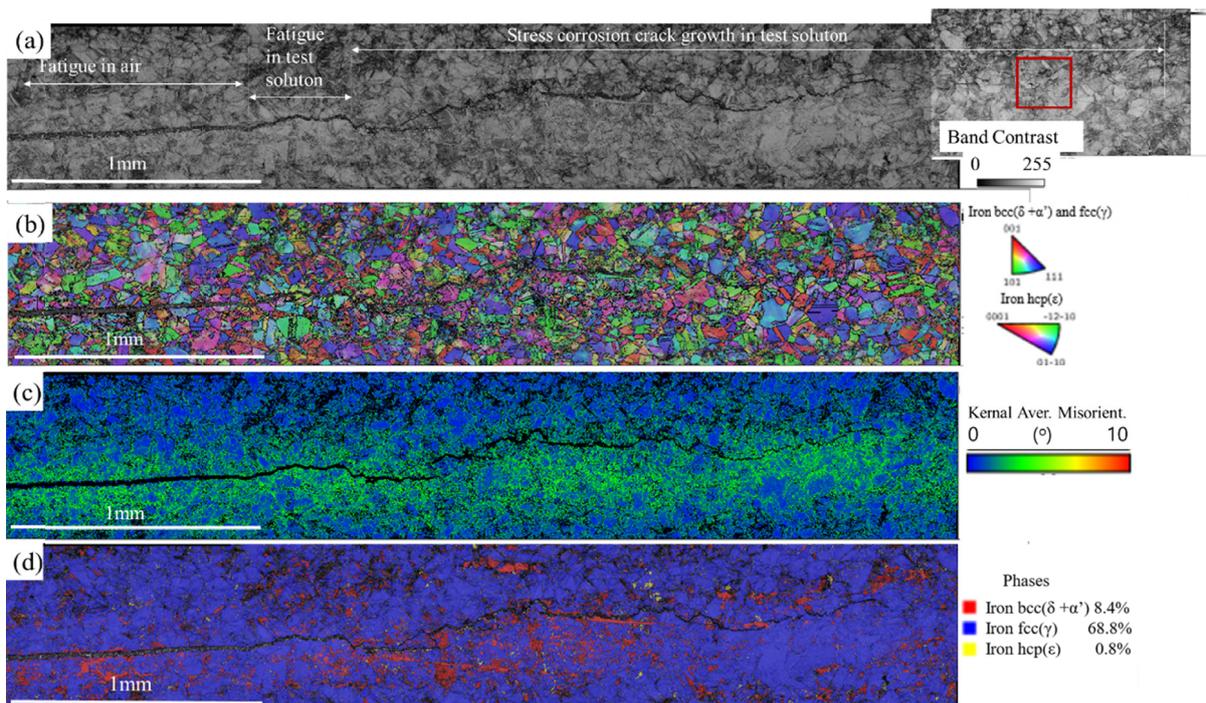
Fig. 1 shows the features around the crack at the side surface, where (a) is the band contrast image; (b) the inverse pole figure; (c) the Kernel average misorientation; and (d) the phase map. All fatigue precracking was performed at $K_{\text{max}} = 30 \text{ MPam}^{1/2}$ and $R = 0.5$. Fatigue precracking was applied to transit cracking path from the transgranular cracking mode to the intergranular mode because many studies reported that SCC of 20% stainless steel in primary water propagates in the IGSCC mode [4]. However, in this study, SCC propagated mostly in the TGSCC mode and rarely in the IGSCC mode as shown in Fig. 1(b). The cracking mode at the crack tip region with a red rectangle in Fig. 1(a) was

Fig. 1. Crack at the side surface: (a) Band contrast image, (b) Inverse pole figure, (c) Kernel average misorientation and (d) Phase map

examined in detail in Fig. 2. Fig. 1(c) shows that plastic deformation around the crack was produced by the applied load during the SCC test. The plastic zone size r_p , measured in Fig. 1(b) was about 0.2 mm. That, given by $r_p = 1/6\pi \times (K/\sigma_y)^2$ in plane strain condition where σ_y is yield strength, was calculated to be 0.1 mm. The plastic zone size measured in Fig. 1(c) deviated from that calculated probably because the 1/2 T CT specimen used in this work was not in the plane strain condition. Fig. 1(d) shows that phases of the 20% cold worked specimen are composed of austenite (blue), δ -ferrite (red) α' martensite (red) and ϵ martensite (yellow). δ -ferrite and α' martensite are not discernible with the crystal structure so they were marked red in the image. However, δ -ferrite and α' martensite are discernible by their shape. δ -ferrite is rather thick while α' martensite has a sharp line. In addition, δ -ferrite is elongated but has no relationship with slip plane while α' martensite is formed on slip plane and it looks like elongated along slip plane. Most of the deformation induced martensite is α' martensite. Both α' martensite and ϵ martensite were produced on the $\{111\}$ plane of austenite. The presence of martensite may not affect TGSCC susceptibility because the TGSCC path was not related to the $\{111\}$ plane with martensite.

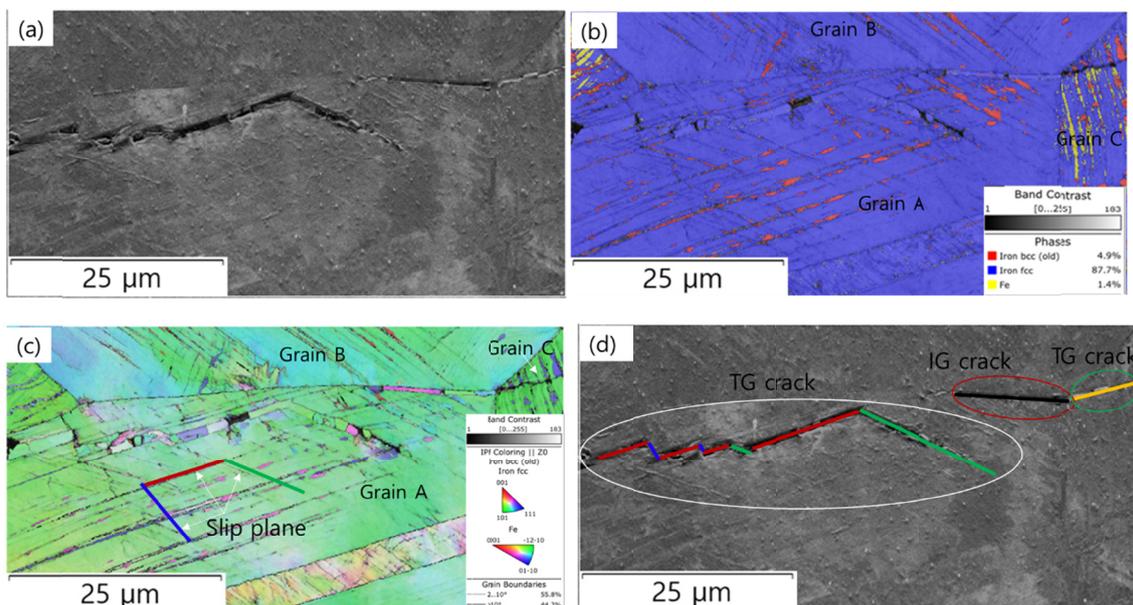
Fig. 2 shows the features around the crack tip at the side surface of the CT specimen, where (a) is the SEM image; (b) the phase with the band contrast image; (c) the inverse pole figure with the band contrast image with; and (d) duplication of (a) with superposition of the cracking path. The SCC crack in grain A of Fig. 2(a) propagates in a zigzag mode. Most of the deformation induced martensite is α' martensites that are aligned along the slip plane as shown in grain A of Fig. 2(b) and ϵ martensite in grain C of Fig. 2(b) is also aligned along the slip plane as α' martensites. Slip lines are overall straight in a macroscale but slightly curved in a microscale, especially in grain C of Fig. 2(b) because of the 20% cold work. Slip lines parallel to the red line and green line in grain A of Fig. 2(c) are well distinguished by both the band

Fig. 2. Enlarged view of the crack tip at the side surface: (a) SEM image, (b) Phase with band contrast, (c) Inverse pole figure with band contrast and (d) Superposition of the cracking path on the SEM image of (a)

contrast image and the martensite formed on the slip lines. The slip line parallel to the blue line in grain A of Fig. 2(c) is also identified by a faint band contrast while deformation induced martensite on the slip line parallel to the blue line is not visible because the amount of deformation on the slip plane parallel blue line is less than the slip planes parallel to the red line or green line. The fourth slip plane of grain A in Fig. 2(c) was identified by a pole figure. The Pole figure of grain A shows that the fourth slip plane normal in grain A of Fig. 2(c) is almost perpendicular to the loading axis, so trace of slip line of the fourth slip plane is implicit in Fig. 2(c) because the resolved shear stress on the fourth slip plane is almost zero. In the FCC crystal structure, there are four slip planes and three slip directions on each slip plane and therefore 12 slip systems. Slip planes can be identified from the band contrast image but slip directions can not be identified from that. The amount of deformation on the slip plane is proportional to the Schmid factor. By comparing Figs. 2(a), (b) and (c), the cracking mode was marked in Fig. 2(d), where cracks in both the white elliptical circle in grain A and the green elliptical circle in grain C propagated in the transgranular mode while the crack in the red elliptical circle between grain A and grain B propagated in the intergranular mode. Cracks marked with the same color in the white elliptical circle are in the same $\{111\}$ plane in Fig. 2(d). The crack in the white elliptical circle seems to have the strongest tendency to propagate along the red $\{111\}$ plane and then along the green $\{111\}$ plane and least along the blue $\{111\}$ plane. The crack along the fourth slip plane in Fig. 2(c) was not observed because there was no slip on that plane and very low tensile stress on that plane.

and Fig. 3, we can surmise that the red and blue lines in Fig. 3 correspond to those in Fig. 2(d). Therefore, the cracking planes A, B, C in Fig. 3 may be on the $\{111\}$ plane. The step between two cracking planes marked by the blue line in Fig. 3 may be another $\{111\}$. The boundary between the red and blue lines is a river line.

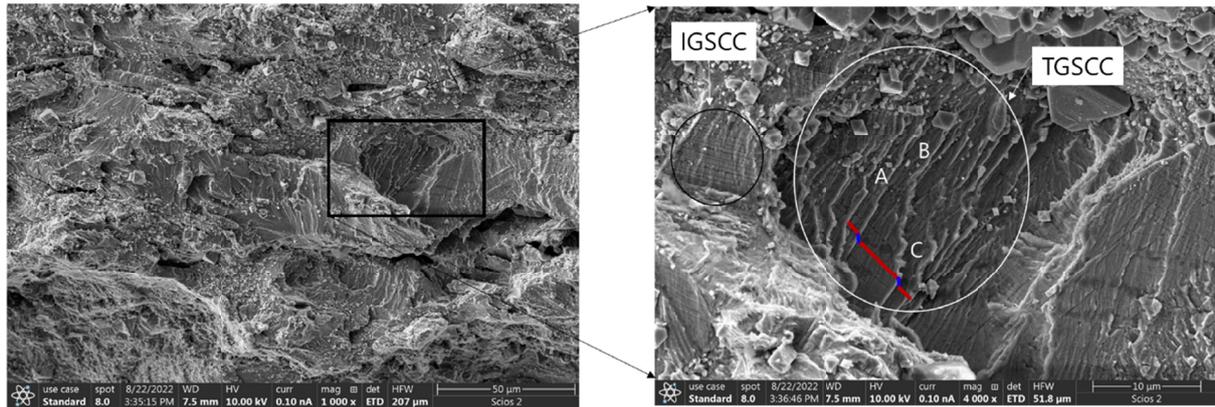
Fractography near the SC crack tip (Fig. 3) shows that the crack propagated mostly in the TGSCC mode. The cracking planes marked A, B and C appear to be parallel to each other and the interfaces between two cracking planes are straight, suggesting that TGSCC has crystallographic features. By comparing Fig. 2(d)

Fig. 3. Fracture surface at the crack tip region showing TGSCC and IGSCC
