Soil erosion control in immature oil palm plantation

For citation: Satriawan H., Fuady Z., Fitri R. 2021. Soil erosion control in immature oil palm plantation. *Journal of Water and Land Development*. No. 49 (IV–VI) p. 47–54. DOI 10.24425/jwld.2021.137095.

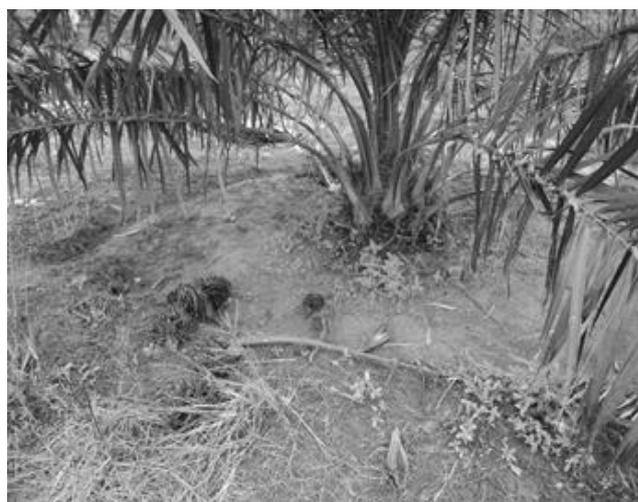
Individual terraces have a length and width 1.5 × 1.5 m and a depth of 20 cm (Photo 1, Fig. 1). Sediment traps are long and wide soil trenches, measuring 1.5 m long, 1 m wide, and 0.5 m depth, made in the midst of planting rows perpendicular to slope direction (Photos 2a, b). The community designed the bench terraces, perpendicular to slope direction, with 3 m width and 1.5–2 m height (Photo 3). Bench terraces were constructed when preparing land for oil palm planting. Leguminous cover crops were grown with spacing of 20 cm × 30 cm.

Photo 1. Individual terrace in plot of land capability class III (phot. Fauzan)

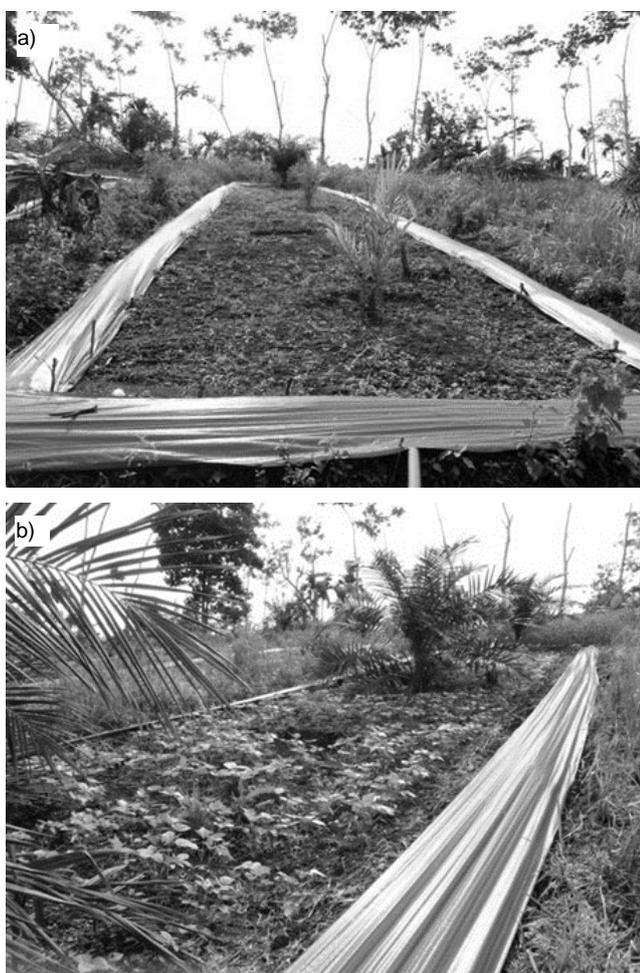
Photo 2. Soil conservation technologies applied in the experiment of land capability class IV: a) sediment trap, b) sediment trap + cover crop + manure (phot. Fauzan)

The treatment on land capability class IV involved the use of sediment trap (P1), sediment trap combined with vertical mulch (P2), as well as a sediment trap, cover crops, and manure (P3). Results showed that treatment with sediment traps cover crops, and manure (P3) significantly reduced surface runoff, soil erosion, and nutrient leaching (Tab. 2).

The treatment by sediment trap, cover crops, and manure (P3) on class IV land was appropriate in controlling surface runoff and soil erosion ($129.40 \text{ m}^3\cdot\text{ha}^{-1}\cdot\text{y}^{-1}$ and $11.39 \text{ Mg}\cdot\text{ha}^{-1}\cdot\text{y}^{-1}$) compared to others ($p < 0.05$). Surface runoff volumes were in the order of $\text{P3} < \text{P2} < \text{P1} < \text{P0}$. Compared with the control treatment, the runoff of P1, P2, and P3 reduced by 9.03, 23.19, and 37.95%, respectively, with significantly different treatments, except for P0 and P1. The soil conservation treatment reduced soil erosion by 50.80, 52.52, and 63.97%, respectively, and the P1, P2, and P3 treatments significantly differed with P0. Soil nutrient leaching, runoff, and erosion were affected by the treatment (Tab. 2), in which the percentage of C-organic and phosphorus were significantly affected. However, the treatment did not affect nitrogen and potassium nutrient removal. In this group, the sediment trap + cover crop + manure (P3) treatment did not prevent nutrient leaching.

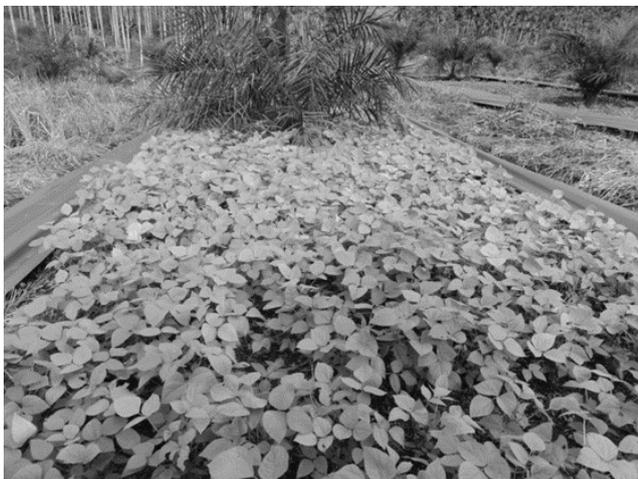
Photo 4. Individual terrace + cover crop + manure in plot of land capability class III (phot. Fauzan)

The soil conservation technologies applied in this study included single individual terraces (creating dishes around the oil palm canopy), individual terraces combined with crop strips, and cover crop (soybeans) together with manures. The treatment applied to oil palm plantations on land capability class III significantly influenced surface runoff, soil erosion, and C-organic and nitrogen leaching. However, there was no effect on the leaching of phosphate and potassium (Tab. 1). Soil conservation treatment significantly affected surface runoff volume and soil erosion. The P3 treatment was the most effective on surface runoff and soil erosion ($22.63 \text{ m}^3\cdot\text{ha}^{-1}\cdot\text{y}^{-1}$ and $13.04 \text{ Mg}\cdot\text{ha}^{-1}\cdot\text{y}^{-1}$) compared to other treatments ($p < 0.05$). The volumes of surface runoff were in the order, $\text{P3} < \text{P2} < \text{P1} < \text{P0}$. Compared to control treatments, surface runoff in P1, P2, and P3 decreased by 30.25, 47.78, and 69.66%, respectively, with significantly different treatments. Soil erosion had a similar trend order as surface runoff, with a reduction of 19.02%, 28.86%, and 47.65%. The P3 was effective for runoff intercept, due to the high density and large ground soybean coverage, resulting in the lowering of raindrop splash erosion compared to other treatments. Soil conservation treatment influenced nutrient leaching, runoff, and erosion (Tab. 1), in which the percentage of C-organic and total nitrogen were signifi-

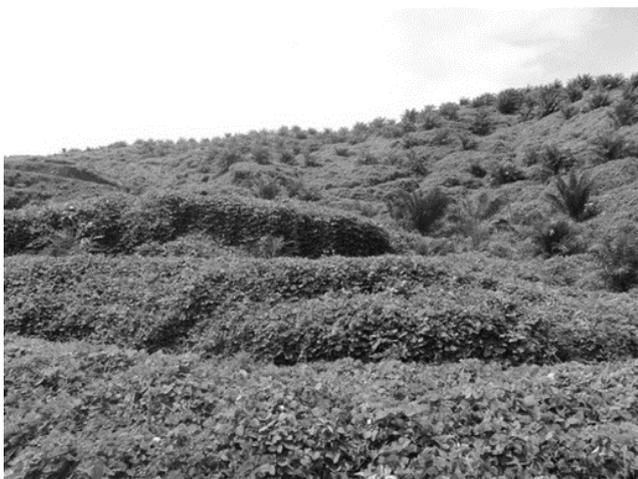
Photo 5. Bench terrace + cover crop in plot of land capability class VI (phot. Fauzan)

Soil conservation treatment on land capability class VI significantly reduced erosion and runoff more than the control treatment ($p < 0.05$) – Table 3. The bench terrace + cover crop + manure treatment significantly reduced surface runoff by 63.59%, compared to the control treatment, followed by bench terrace + cover crop (56.16%) and bench terrace (45.26%), respectively (Photo 4). The bench terrace + cover crop + manure (P3) reduced soil erosion more than other treatments, 64.73% compared to other erosion controls. Soil nutrient leaching, runoff, and erosion were greatly influenced by the conservation treatment applied (Tab. 3 and Photo 5), in which the percentage of C-organic and total nitrogen were significantly affected by the P3 treatment. However, phosphate and potassium leaching was not affected by the treatment. In this group, bench terrace + cover crop + manure (P3) was the most effective in preventing nutrient leaching.
