Our Beaches

ZBIGNIEW PRUSZAK, RAFAŁ OSTROWSKI

Institute of Hydroengineering, Gdańsk Polish Academy of Sciences zbig@cyklon.ibwpan.gda.pl rafi@cyklon.ibwpan.gda.pl

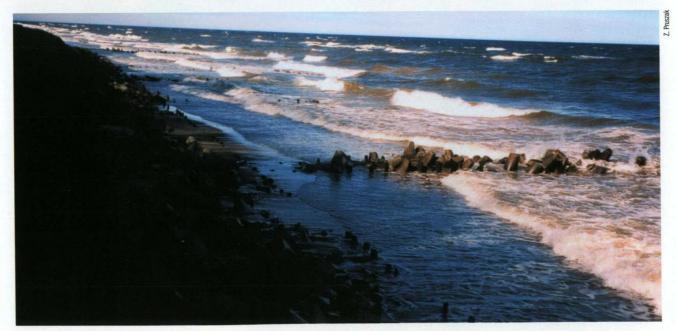
Disappearance of the beach near Rewal due to intensive erosion. Heavy shore protection measures (rubble-mound seawall and groins) proved to be ineffective

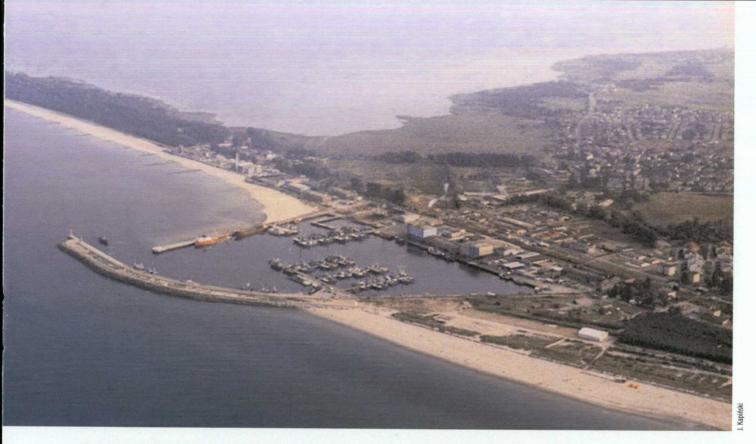
Władysławowo harbor at the root of Hel Peninsula. The natural littoral system has been affected by harbor breakwaters
